RE: INDIAN POND PROJECT, FERC NO. 2142
STUDY PLANS FOR FISHERIES ENHANCEMENTS

Indian Pond Project, FERC No. 2142

Section 3.3.3.C Field Evaluation of Potential Aquatic Restoration Projects

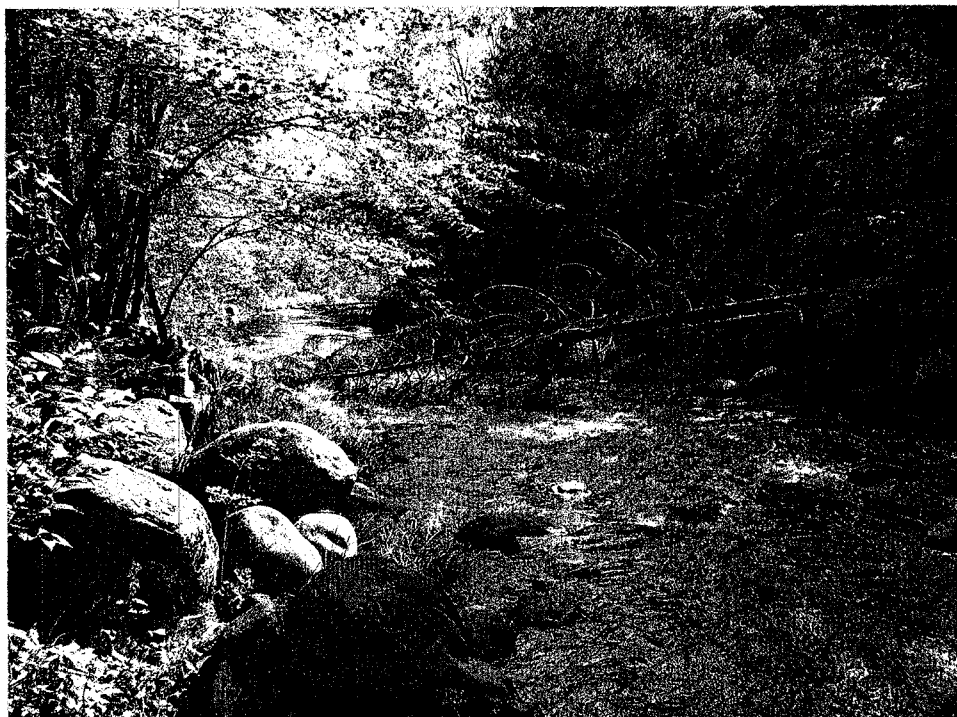
Figure 2. Cold Stream at CS3 (view downstream).

Channel conditions in Cold Stream were assessed at three locations (CS1, CS2, and CS3 on Figure 1). For most of its length, Cold Stream provides excellent brook trout habitat for both adults and juveniles (Bonney, 2005, p. 7). In its upper reaches at the CS3 site (and probably upstream to the falls in Cold Stream valley), the channel is moderately entrenched, boulder-dominated, with a high width/depth ratio (B2 type) and steep gradient (0.02, estimated from the USGS 7.5 minute quadrangle map). The channel is relatively narrow (4 to 6 m) with low, stable banks composed predominantly of cobble and boulder materials. Pools 1 to 3 m wide and estimated to be 0.5-1 m deep occur every 18 to 20 m, with irregularly-spaced ones formed by large woody organic debris fallen into the channel (Figure 2). Channel bed material appeared to consist predominantly of well-armored cobble and rubble.

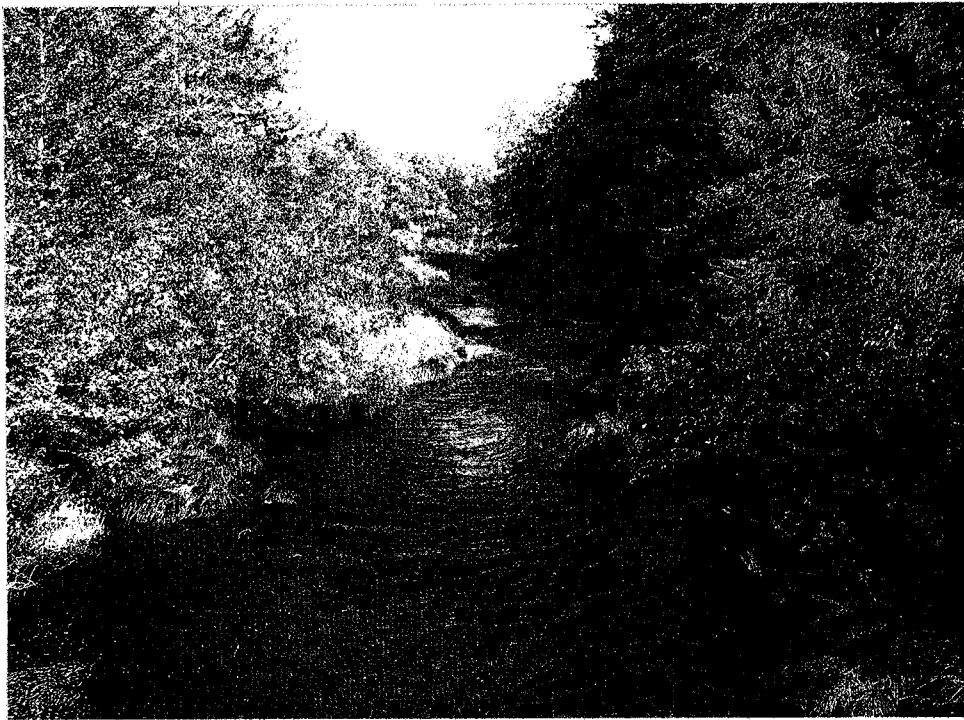
Figure 3. Cold Stream at CS2 (wooden bridge near Capitol Road bridge; view upstream).

Near the Capitol Road bridge (CS2), Cold Stream is moderately entrenched (C2-type), with a moderately steep gradient (0.011) and 5 to 6 m wide, stable banks. A meandering thalweg flows between alternating longitudinal bars and riffles spaced every 10 to 15 m. Flow depths estimated to be up to 0.5 m. Channel substratum looked to be mostly gravel and cobbles; point bars were entirely submerged during our visit (Figure 3). The adjacent stream banks and floodplain are well-vegetated with grass and low shrubs. Old wooden bridge abutments were sticking out of the bank beneath the modern-day wooden bridge. The extent to which log drives have altered the channel morphology is indeterminable, but its current condition appears stable.

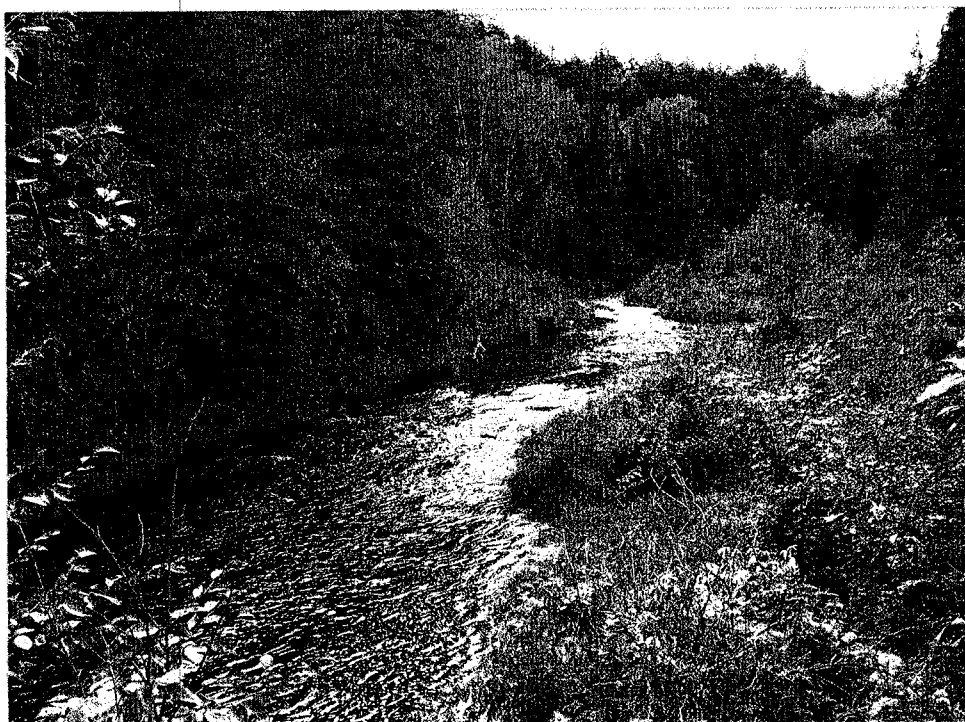
Approximately 0.5 km upstream its junction with Tomhegan Stream, Cold Stream is accessible from a gravel road (CS1). Old topographic maps indicate a dam was built here, presumably for logging. Remains of the dam were not detected during the site assessment and its precise location remains unknown. However, the valley width narrows to 17.5 m at this location and steep slopes on east banks (visible in Figure 4) suggest the headwall of the dam was located near the present-day gravel road abutments on either side of the valley. Upstream of this point, the channel becomes noticeably wider and shallower, and the stream bifurcates around several large, vegetated bars (Figure 4). From the vantage point of the west valley side, it appears that channel continues to store a significant quantity of coarse sediment upstream of the former dam site. It is well vegetated and appears stable and not actively being transported. However the channel gradient is reduced and the stream because wide and shallow for a distance of several hundred meters downstream.

Figure 4. Cold Stream at CS1 (view upstream of channel at former dam site).

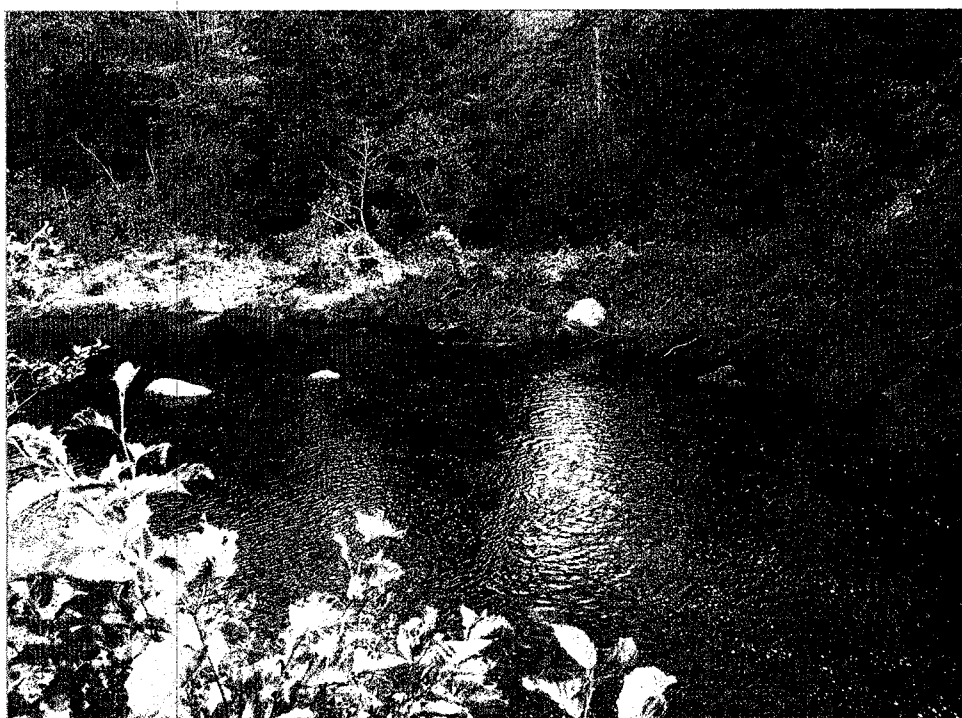
Several broad, shallow pools exist in this reach. The channel widens downstream of the gravel road abutment (Figure 5). Elongated bars up to 5 m long and composed of what appeared to be gravel and cobble-sized material create two or three broad pools. However, the channel lacks significant structure. Large organic debris was absent from the channel in this reach. Further downstream, an overbank flow channel, with flood debris jammed in the riparian vegetation, exists in the low-lying area on the right side of the channel. The stream appears to steepen and narrow further downstream.

Figure 5. Cold Stream at CS1 (view downstream from gravel road abutment toward right bank).

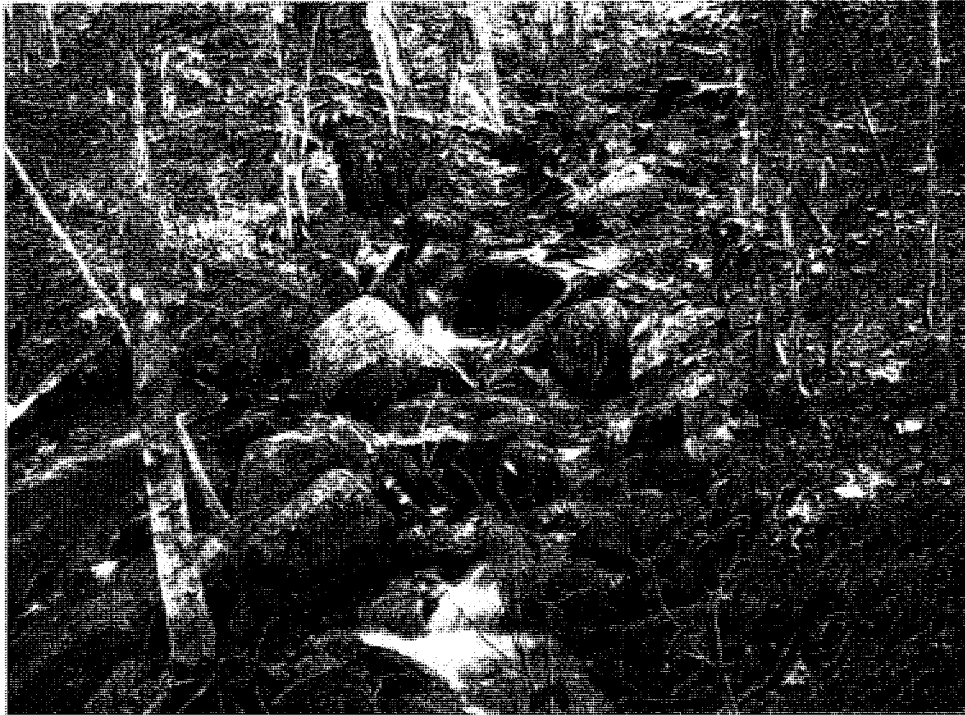
Figure 7. Fish Pond Stream at FPS1, near its junction with the Kennebec River (view upstream).

Over most of its length, Fish Pond stream is a steep, cascading stream (A2b type) flowing down the steep east valley side of Kennebec River near its gorge section. The stream channel is generally narrow, 2 to 4 m wide, with low banks. The water was clear, cold (15 °C), and flowing in and out of hyporheic zone in the bouldery stream banks. Water flow in the main channel plunges through small intermittent pools up to 1 m across and 0.65 m deep and spaced every 6 to

10 m. The substratum consisted of loose, coarse gravel and cobbles. Large boulders within channel provided numerous chutes and pools. Stream flows most of its length through a mature forest, with well-vegetated floodplain.

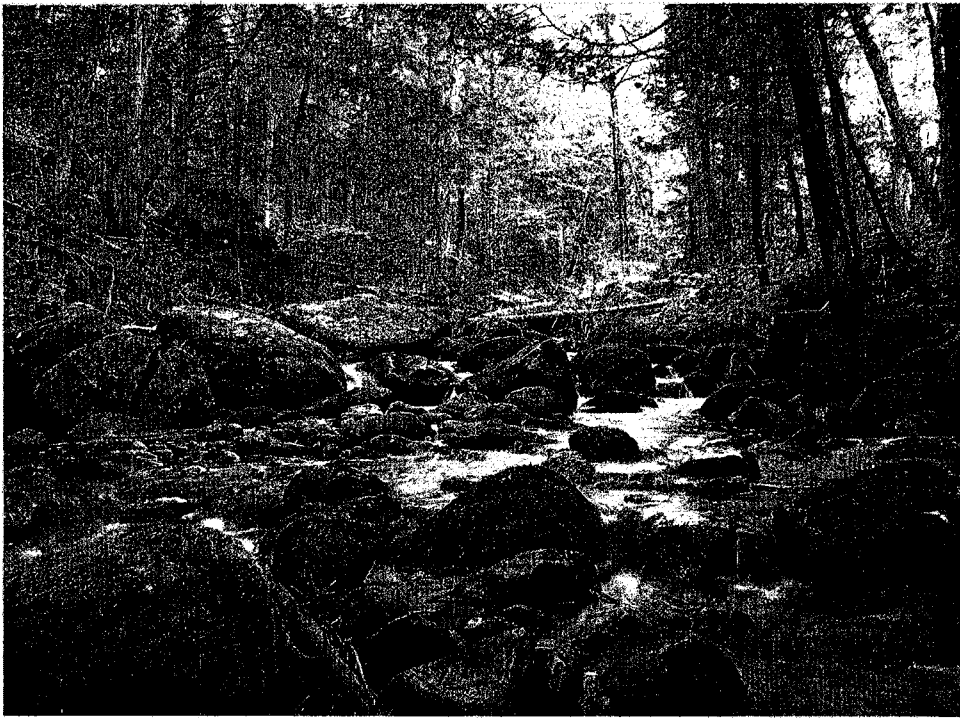
Durgin Brook is accessible downstream of a Route 201 (DB1, DB2, and DB3). Here, the stream is a B3c type, moderately entrenched channel developed in very coarse materials with a steep channel gradient of 0.025 (estimated from USGS topographic map). The channel bed morphology appears to be dominated by cobble and boulders and characterized by a series of rapids with irregularly spaced pools up to 3 m across and estimated to be 0.2 to 0.6 m deep. Channel widths averaged 5 to 6 m wide with stable banks extending 0.8 to 1 m above the channel bottom. The large cobbles and boulders originated from lag deposits that are the result of continental glaciation. Gravelly substratum, with numerous chutes and eddies behind boulders near edges of channel. Mostly wooded, shaded reach, with fallen trees and roots providing fish habitat at places along the channel. Water was clear, cold, and appeared well-oxygenated. Numerous invertebrates could be found on the undersides of rocks picked up from the stream bottom.

Figure 8. Durgin Brook at DB2, approximately 150 m downstream from Route 201 culvert.

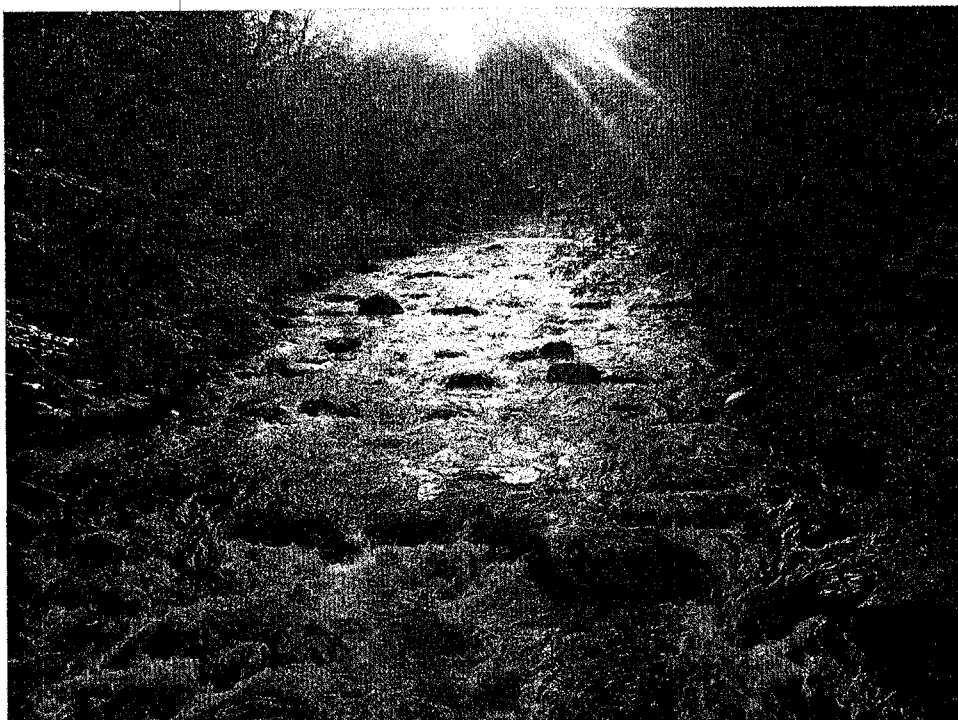
Figure 9. Salmon Stream at SS1 (lower road along Dead River; view upstream).

Salmon stream is accessible downstream of a logging road crossing (SS1). Here, the stream is a C3 to C2 type, slightly entrenched system developed in very coarse glacial materials with an approximate channel gradient of 0.010 (estimated from USGS topographic map). Further upstream, the channel becomes wider and less steep (B3-type morphology). The channel bed is dominated by cobble and boulders and is characterized by a series of rapids with irregularly spaced pools 2 to 4 m across and estimated to be 0.5 to 1.5 m deep (Figure 9). Channel widths were generally less than 8 m, with stable banks extending 0.5 to 2 m above channel bottom (Figure 10). Substratum appeared to be predominantly gravel and cobbles, with numerous boulders up to 1.5 m scattered throughout the channel. Stream was well shaded by the forest canopy, with fallen trees providing good habitat a several places along the channel (Figure 11). Water was clear, cold, and appeared well-oxygenated. Numerous invertebrates could be found on undersides of rocks picked up from the stream bottom.

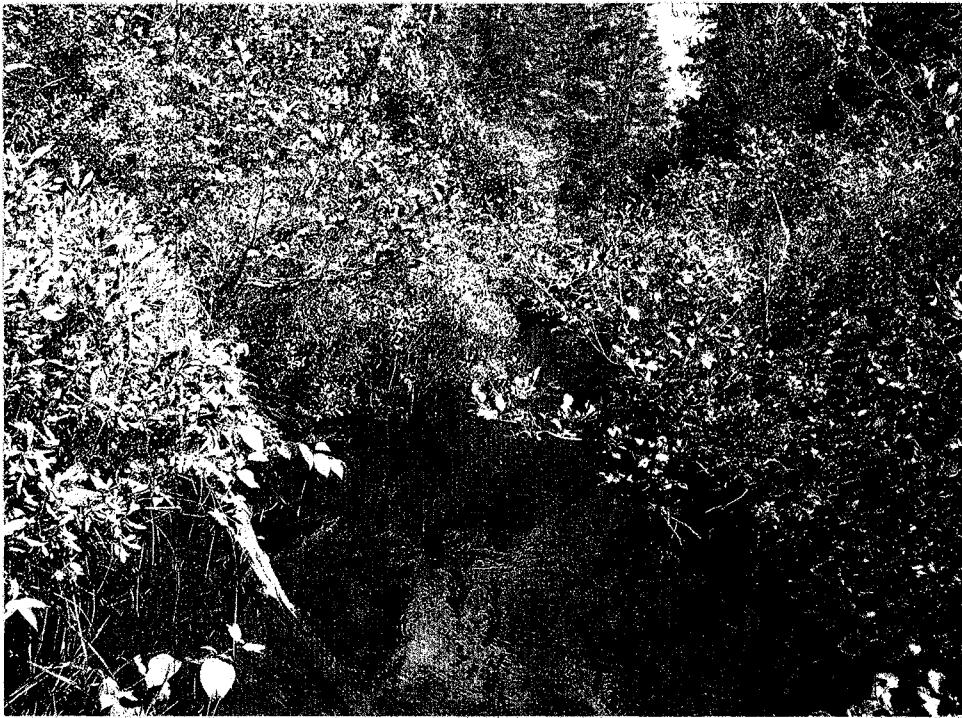
Figure 12. Alder Pond Brook at APB1 (view upstream).

Alder Pond stream is accessible by an unpaved logging road along the Dead River (APS1). Here, the stream is a E4 type, with slightly entrenched channel developed in coarse gravel and cobble materials and a gentle gradient of 0.003 (estimated from USGS topographic map). The channel is characterized by a moderately high width/depth ratio and series of rapids with irregularly spaced pools. Bankfull width were estimated to be less than 6 m wide with stable banks extending 1 to 1.5 m above channel bottom (Figure 12). Substratum appeared to consist predominantly of gravel and cobbles, with small, elongated pockets of gravel along the channel banks in places. Stream is moderately well-shaded, with riparian shrub roots providing limited cover along the edges of channel (Figure 13). Water was clear, slow flowing, and moderately warm (20 °C) as it flows out of Alder Pond, located 0.5 km upstream. Invertebrates were be found on undersides of rocks picked up from the stream bottom.

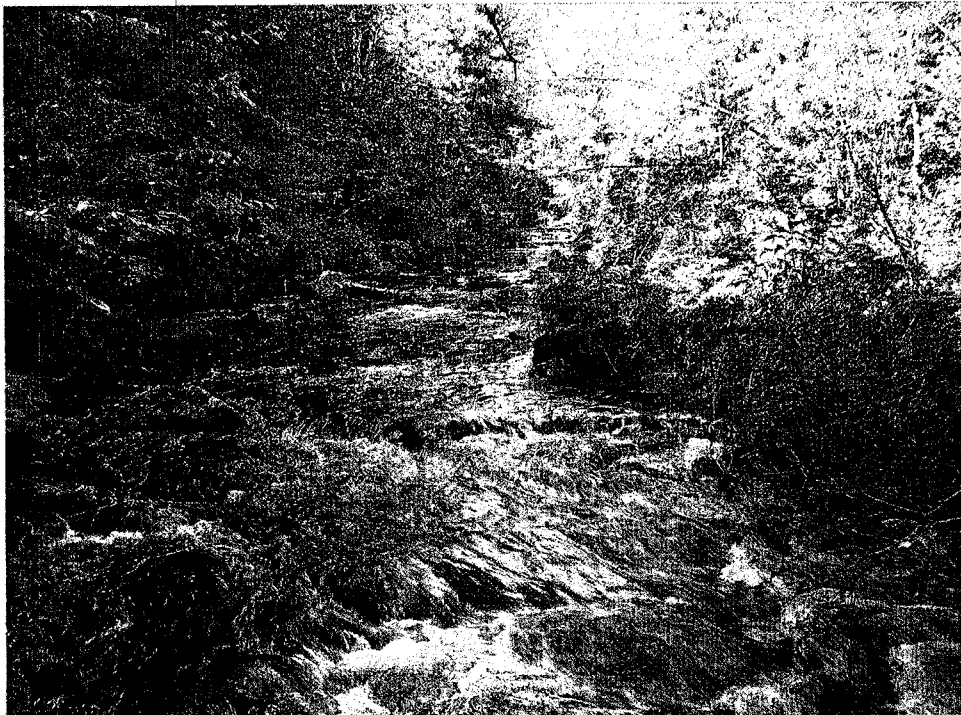
Figure 14. Stony Brook at SB1 (view upstream).

Stony Brook is accessible by an unpaved logging road along the Dead River (SB1). Here, the stream is a E3 type, slightly entrenched system developed in coarse gravel and cobble materials with an approximate channel gradient of 0.006 (estimated from USGS topographic maps). The channel is characterized by a moderately high width/depth ratio and series of rapids with irregularly spaced pools up to 4 m long and estimated to be 0.5 to 1 m deep (Figure 14). Channel widths ranged from 5 to 8 m wide with stable banks extending 0.8 to 2 m above channel bottom. Substratum appeared to consist predominantly of cobbles and boulders, with numerous chutes and eddies behind boulders near edges of channel. Mostly wooded, shaded reach, with fallen trees and roots providing fish habitat a places along the channel. Numerous invertebrates could be found on the undersides of rocks picked up from the stream bottom.

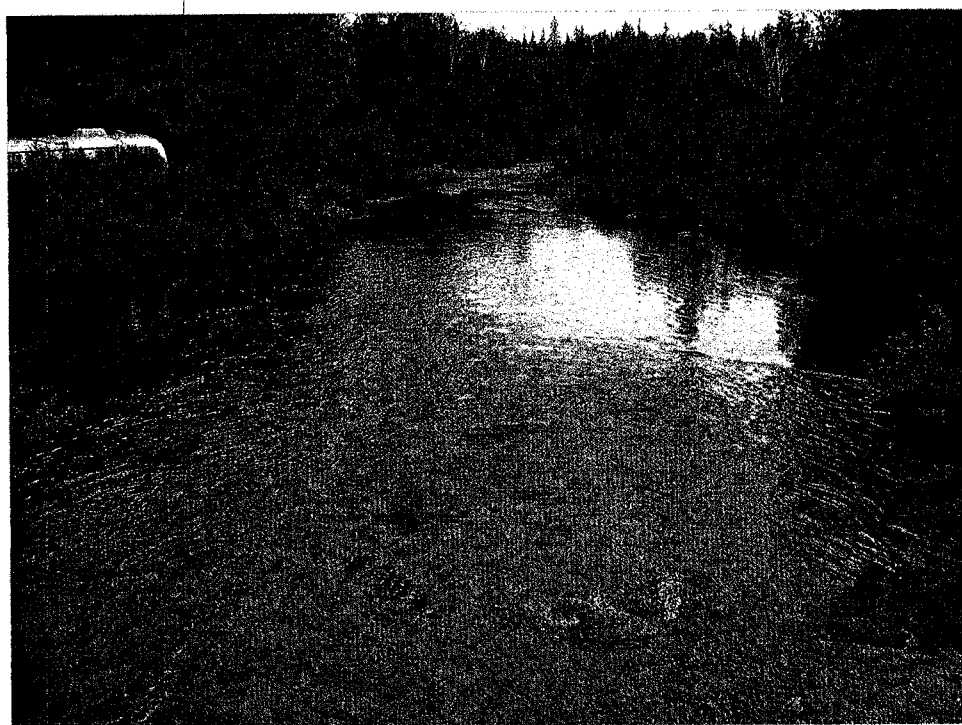
Figure 15. Enchanted Stream at ES1 (Lower Enchanted Road bridge; view downstream).

In its lower reaches, Enchanted Stream is accessible as it flows out of Lower Enchanted Pond (ES1). Here the stream is 11.9 m wide and relatively warm (18.5 °C). On the downstream side of Lower Enchanted Road bridge the channel widens downstream of the bridge, due to a bedrock grade control (Figure 15). A broad backwater area with lily pads exists on the right side of the channel downstream of the bridge. Further downstream, an old pulp chute is present on the left bank (behind the aluminum travel trailer in Figure 15). This feature, along with an unnatural-looking line of boulders in the woods further downstream, are believed to be remnants of former logging operations. A broad, vegetated floodplain is present on both sides of the stream with water flowing visibly through the bouldery hyporheic zone where it exposed around tree roots.

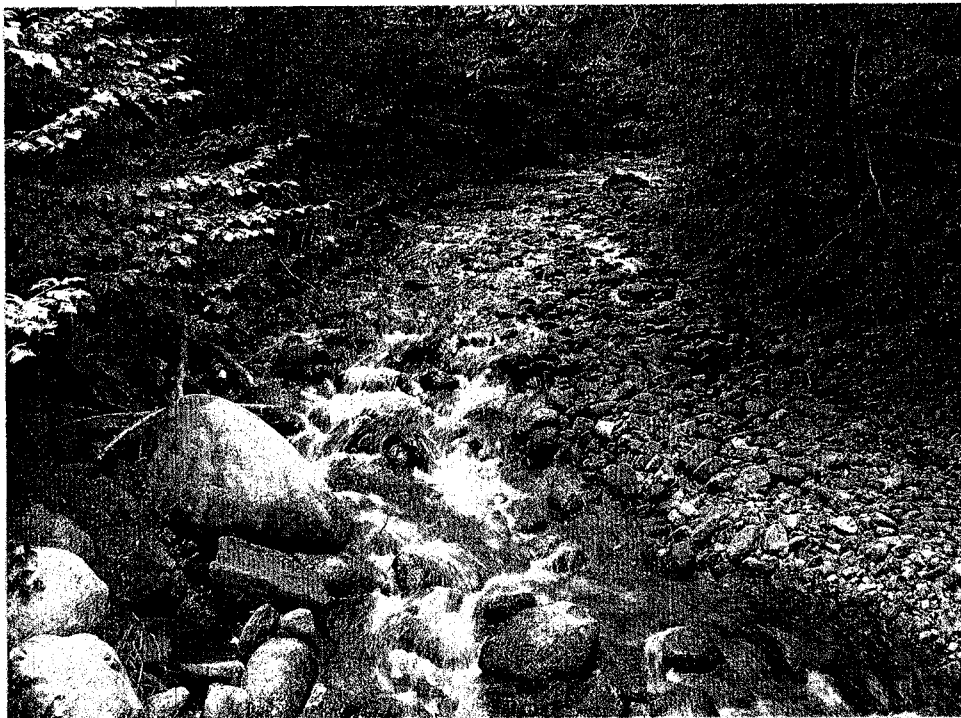
Figure 17. Enchanted Stream at ES2 (view upstream).

As it flows out of Enchanted Pond in its headwater reaches (ES2) is a low-gradient, meandering stream (E3 type), with narrow, grassy channel flowing through broad alluvial valley. Channel bottom appeared to be composed of predominantly cobble-sized material, with elongated pools and occasional alternate gravel bars (Figure 17). The stream meanders through a low-gradient marsh area that has developed naturally on the broad, glaciated "bench" on the side of the Dead River. This regional, low-gradient, bog region extends east-west in a broad band about 1 km wide and is easily visible on topographic map (Figure 1). Numerous natural ponds exist in this area, including Alder Pond, Stony Brook Pond, Lower Enchanted Pond, and Johnson Pond.

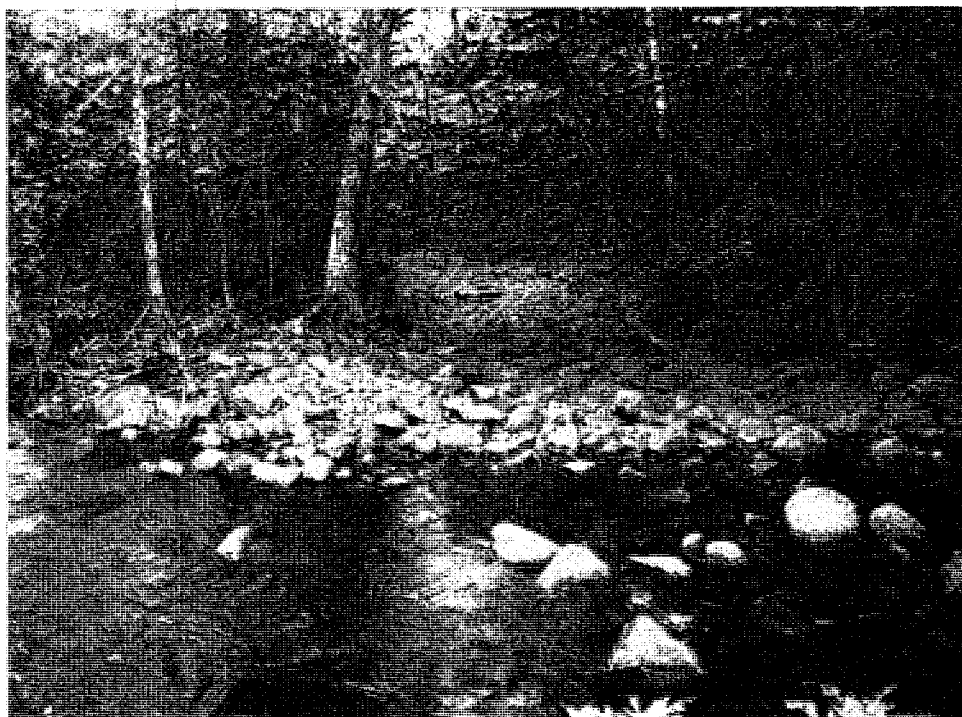
The East Branch of Enchanted Stream is accessible by an unpaved logging road near its junction with Enchanted Stream (ES3). In its upstream reaches (ES4) the stream is well-entrenched, steep B2/B3-type system, with numerous pools and riffles and stable banks. However, further downstream at ES3, the channel is degraded with bank erosion along its left bank extending 40 to 50 m downstream of the logging road bridge. An ATV crossing on the downstream side of the stream further acerbates the channel condition (Figure 18). Here the channel 10.8 m wide, 0.2 m deep and relatively warm. Organic material was largely absent from the stream channel substratum and only one mayfly larvae was found on the rocks picked up off the bottom. Approximately 50 m downstream from the bridge, an abandoned channel is present on the right outside of the meander (Figure 19).

Figure 19. East Branch of Enchanted Stream ES3, approximately 50 m downstream from logging road bridge (view downstream). Abandoned overflow channel extends into woods on floodplain.

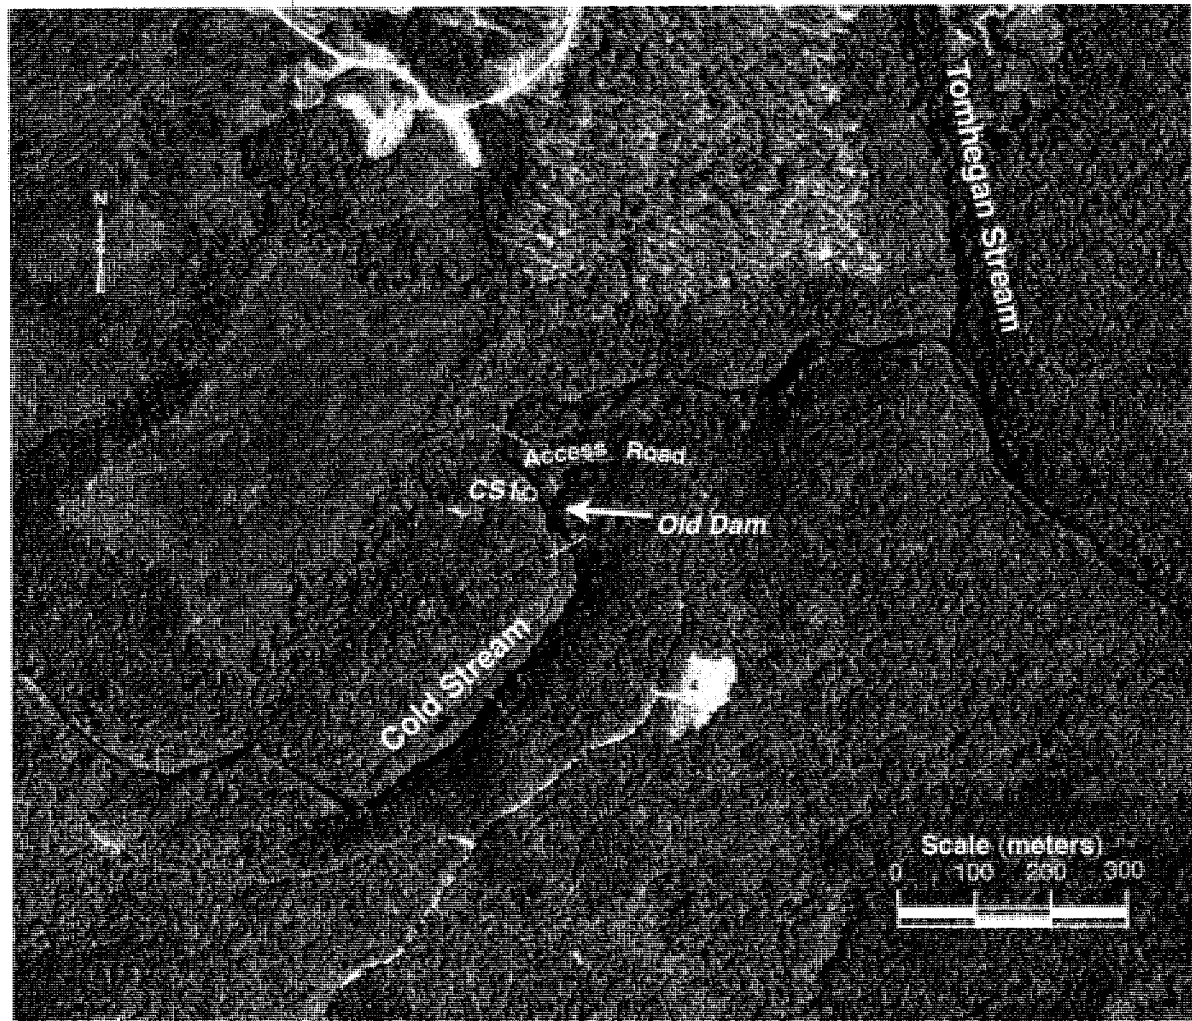
of Enchanted Stream. The Cold Stream restoration area is located at a former dam site. The current channel is a long glide, lacking significant structure. The Enchanted Stream restoration area is located near a recent channel avulsion, which has likely caused the left bank to erode.

Figure 20. Aerial photograph of Cold Stream at CS1, old dam site near its junction with Tomhegan Stream. Section of channel between the two dotted lines is where detailed field studies for channel modification and habitat enhancement measures are proposed.

- (b) Stream improvement measures are recommended in Cold Stream at CS1 (Figure 20) and the East Branch of Enchanted Stream at ES3 (Figure 21). A “natural streams design” approach (Rosgen, 1996; 2001) should be used to design habitat enhancement structures and modify existing channel features. Details regarding this improvement effort is provided in sections 4.1 through 4.3 below.

Based on the preliminary stream assessment, we propose a detailed site investigation be performed at sites CS1 and ES3 to characterize the topographic, geomorphic, hydrologic, and biologic conditions at these locations (Figures 20 and 21).

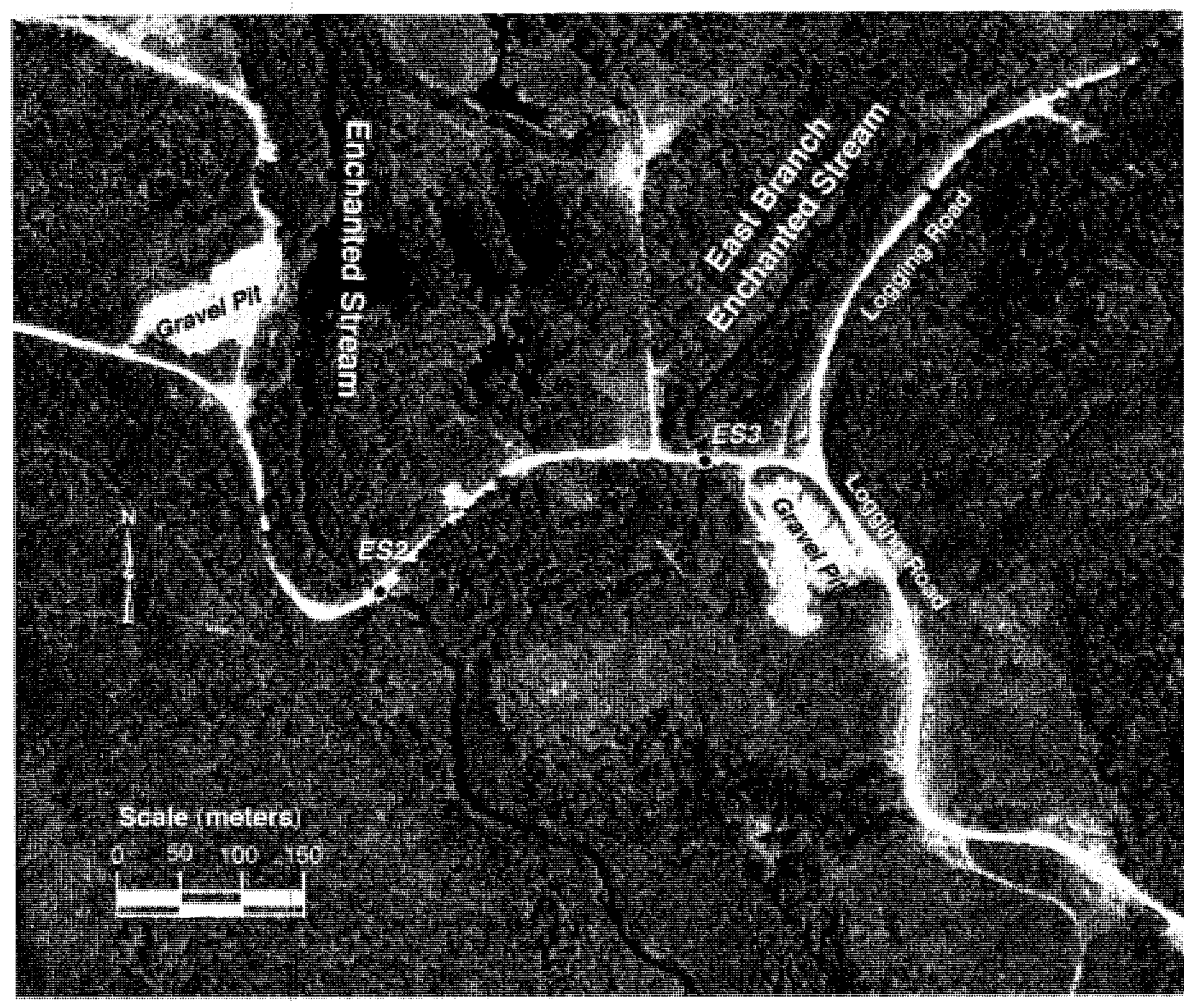
The stream morphology and hydrologic studies should carefully evaluate the stability of Enchanted Stream because of the recent evidence of a channel avulsion. The stream channel may be adjusting as a result of this avulsion so addressing the bank erosion may only cause further erosion downstream.

Figure 21. Aerial photograph of East Branch of Stream (ES3), near its junction with Enchanted Stream downstream of Enchanted Pond. Section of channel between the two dotted lines is where detailed field studies for channel modification and habitat enhancement measures are proposed.

At the ES3 site, bank stabilization measures may improve conditions downstream from the logging road bridge. The banks may be stabilized using bioengineering (deformable) techniques that incorporate elements of large woody debris and anchor rock placement to address near bank shear stress. The intent is to reduce/eliminate stream bank erosion and to stabilize the stream banks while riparian treatments mature. Work will be conducted in areas where there is no evidence of recent spawning. A tracked excavator will most likely be used for placement of rock and wood. Work would occur in areas where access is easy and minimal disturbance of riparian habitat would occur. In-water work would be limited to areas with low flow near the edges of the wetted channel on gravel bars and solid banks. No methods with hard rock (bank hardening) that prevent meandering will be used such as riprap and toe rock. These structures are intended to enhance and provide habitat as well as survival of listed species. The benefits should be felt throughout the seasonal variations in the river systems where they are constructed. Technical expertise for the design of these structures will come from consultants.
