STATE OF MAINE
LAND USE REGULATION COMMISSION

IN THE MATTER OF DEVELOPMENT)	Pre-Filed Direct Testimony of
APPLICATION DP 4889)	David Raphael on behalf of
CHAMPLAIN WIND, LLC)	Champlain Wind, LLC
BOWERS WIND PROJECT)

On behalf of Champlain Wind, LLC, David Raphael of LandWorks is submitting this pre-filed direct testimony in support of the Bowers Wind Project (“Project”).

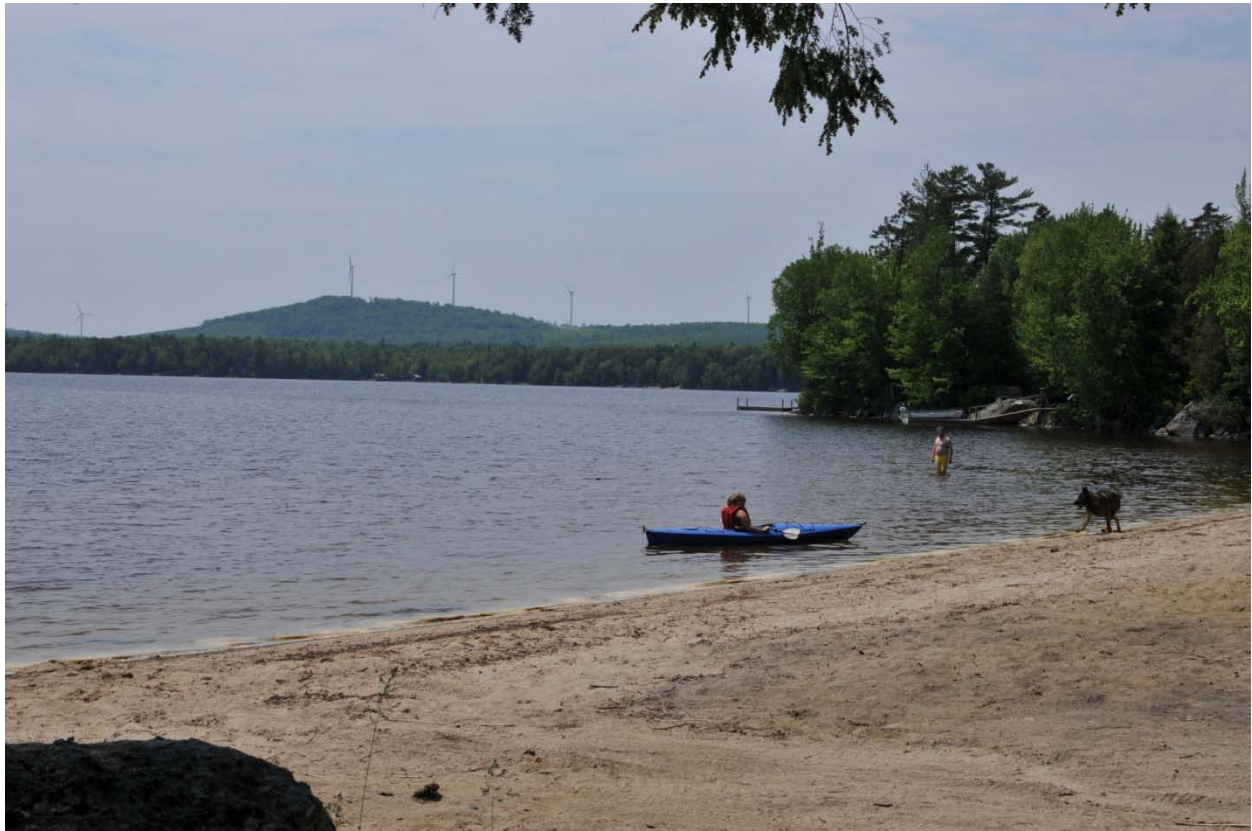
Rollins from northern shore of Madagascal Pond, at public beach and boat launch.

From this location, the closest turbine at Rollins is approximately 2.5 miles away. Photo taken by TJDA, June 6-7, 2011.

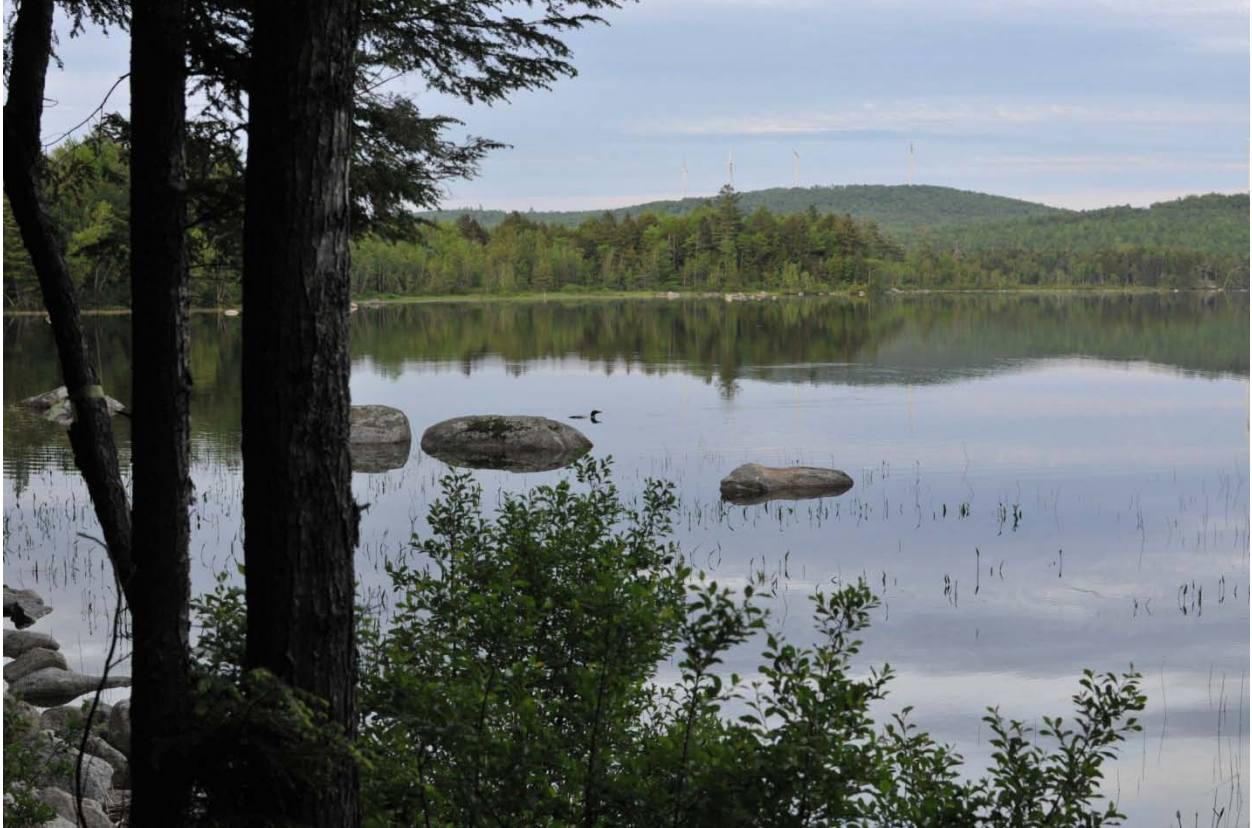
Rollins from Upper Pond. From this location, the closest turbine at Rollins is approximately 2.5 miles away. Photo taken by TJDA, June 6-7, 2011.

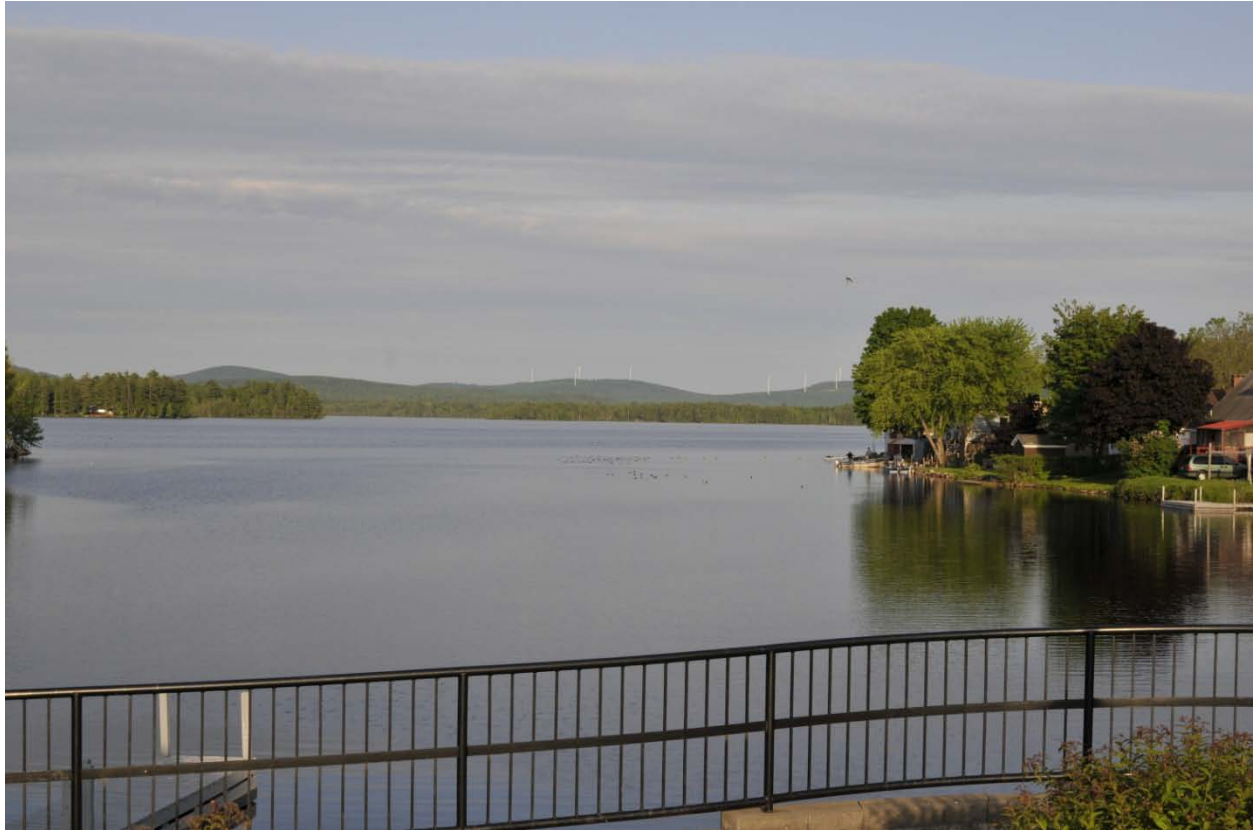
Rollins from gazebo in downtown Lincoln. From this location, the closest turbine at Rollins is approximately 5.5 miles away. Photo taken by TJDA, June 6-7, 2011.

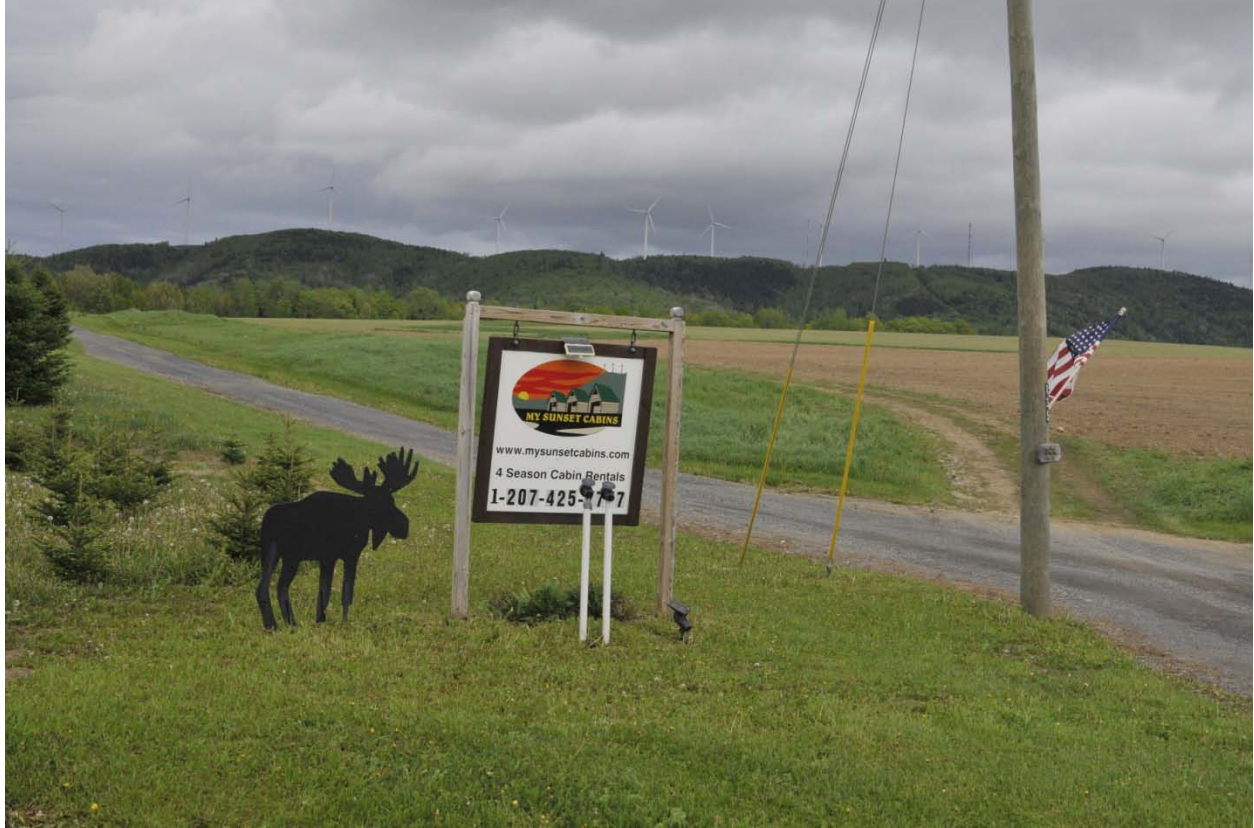
Mars Hill from a road in Mars Hill. Photo taken by TJDA, June 6-7, 2011.

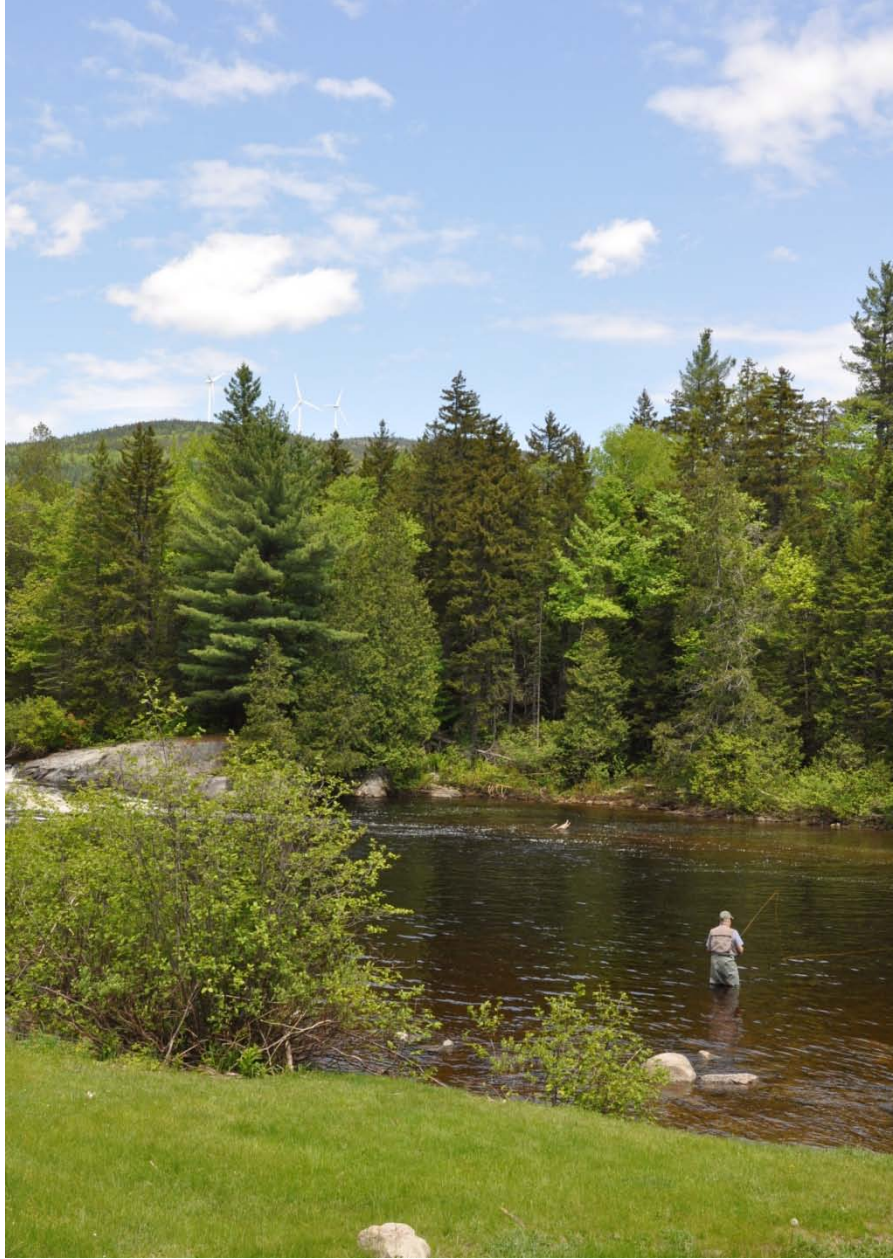
Kibby from Sarampus Falls, near rest area. From this location, the closest turbine at Kibby is approximately 1.5 miles away. Photo taken by Geoff West, June 6, 2011.

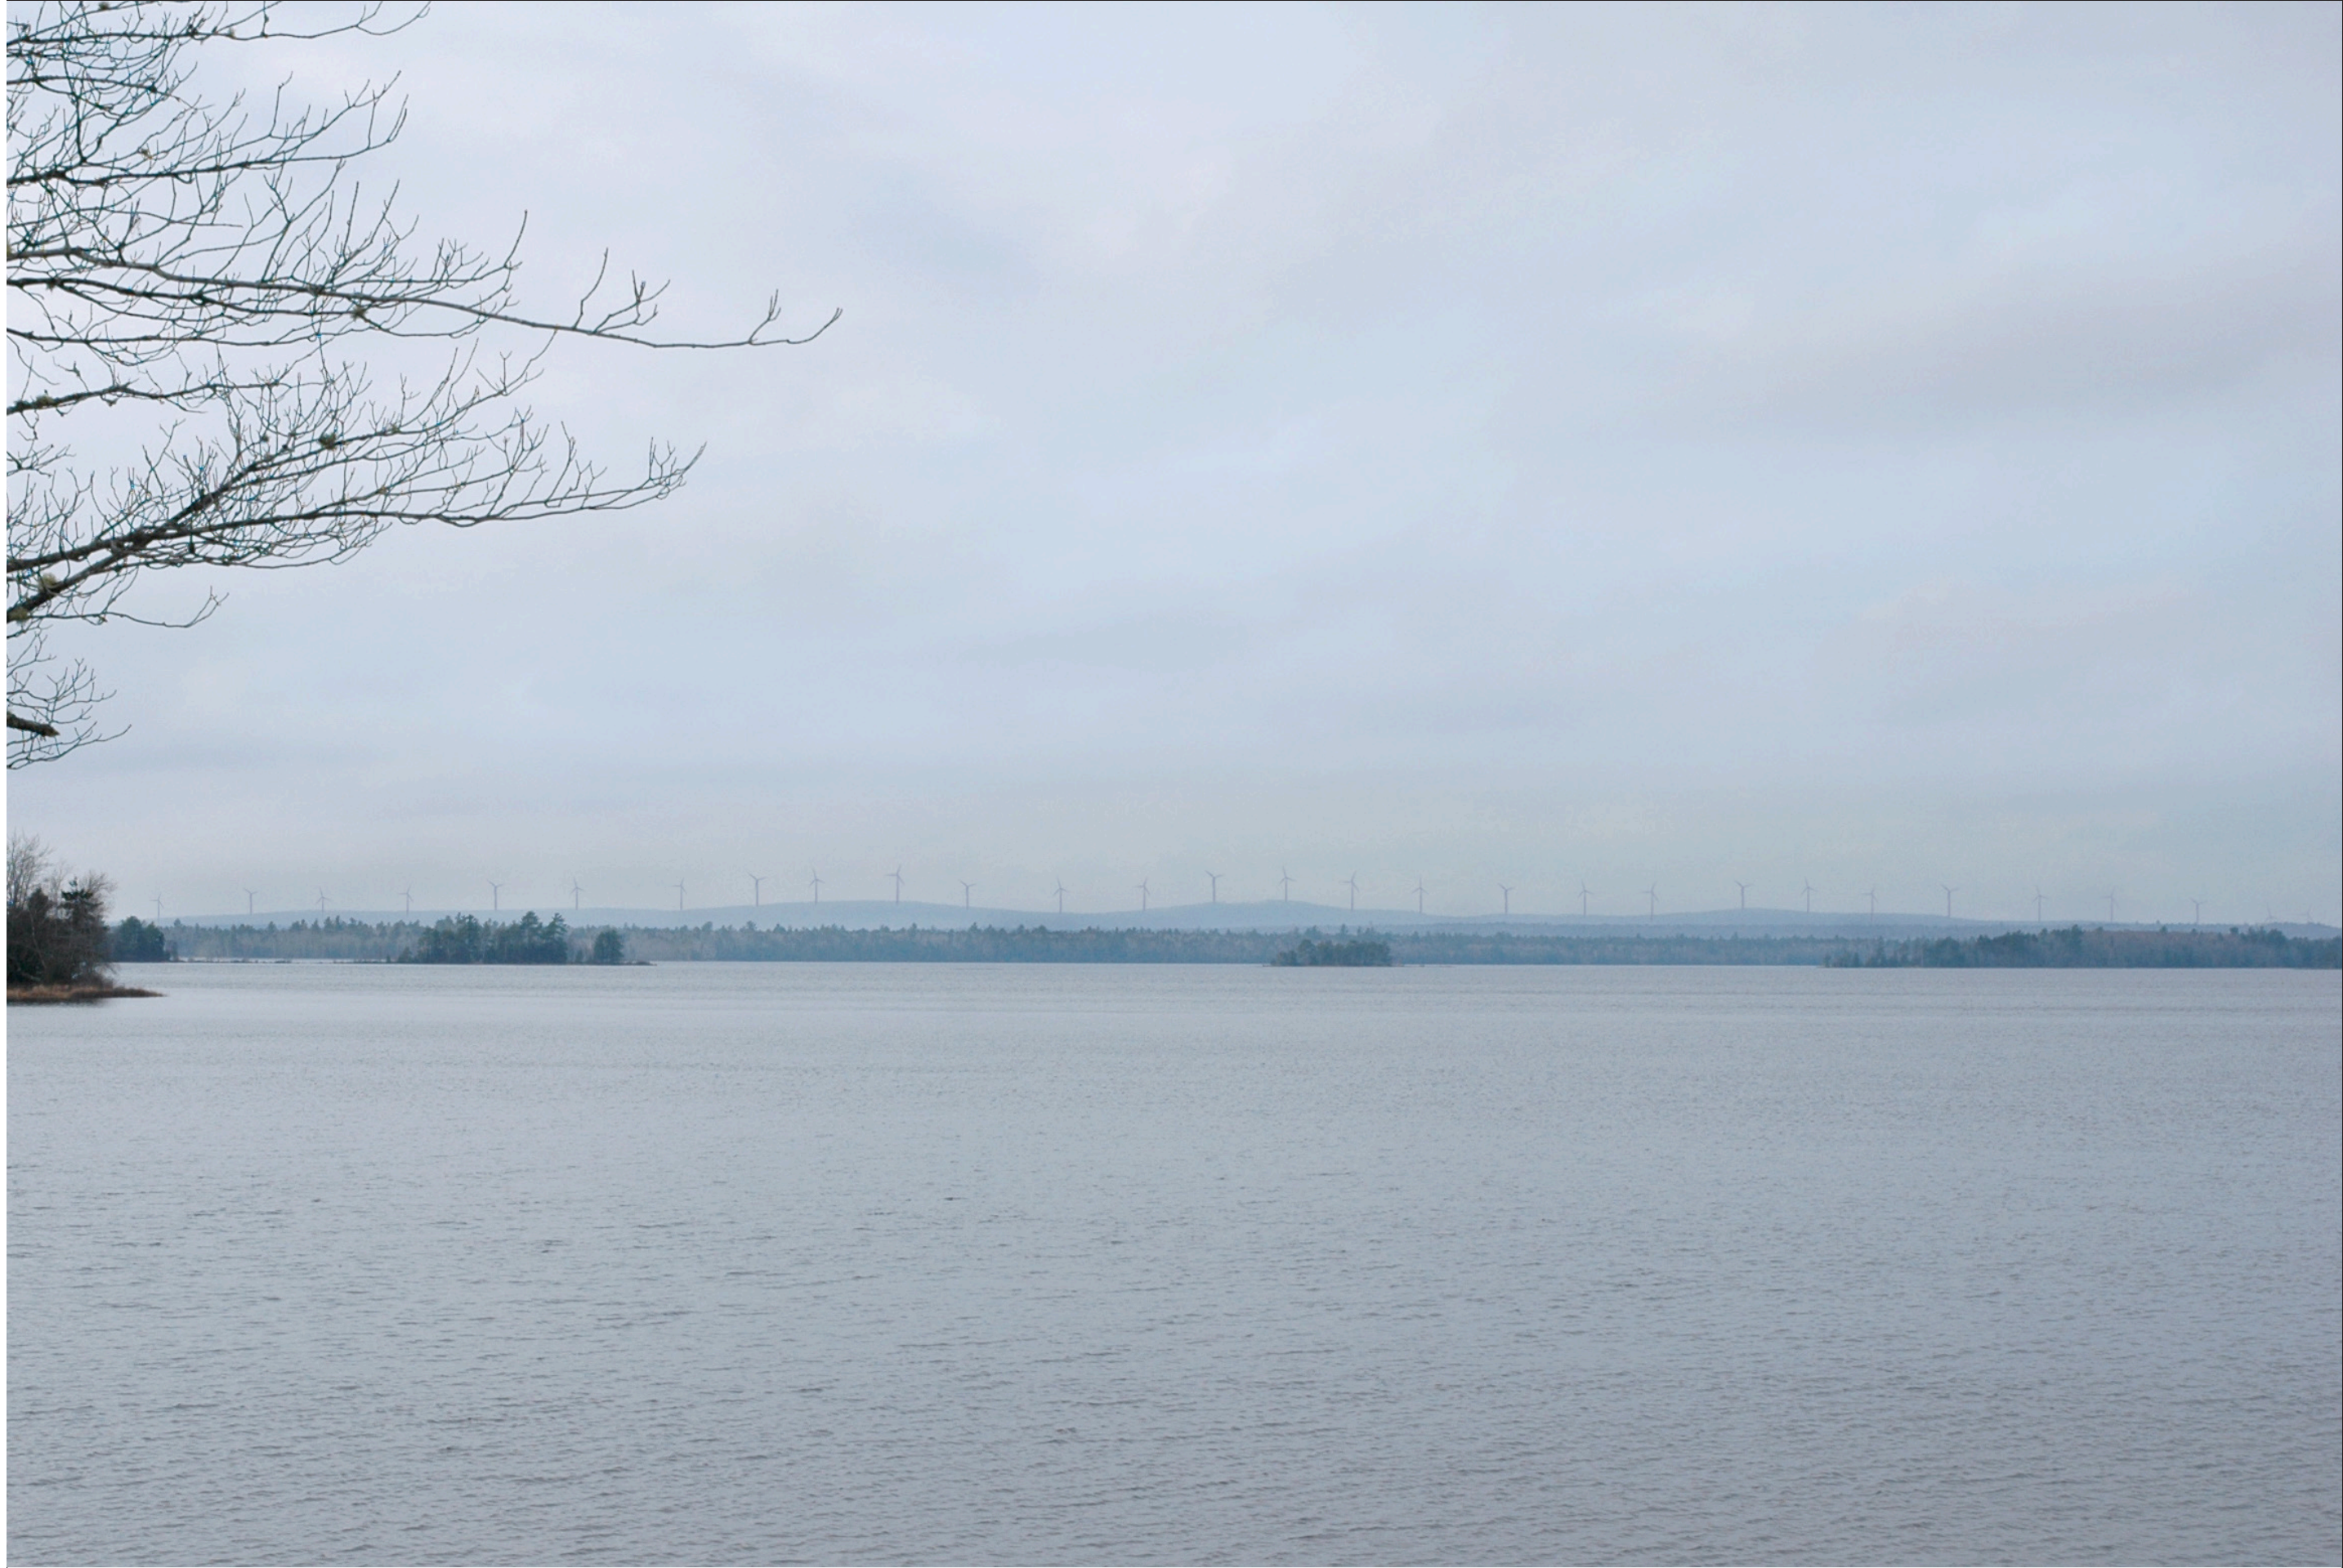
Photosimulation 2 from the boat landing on Baskahegan Lake in Brookton. The closest turbine will be 8.9 miles away.

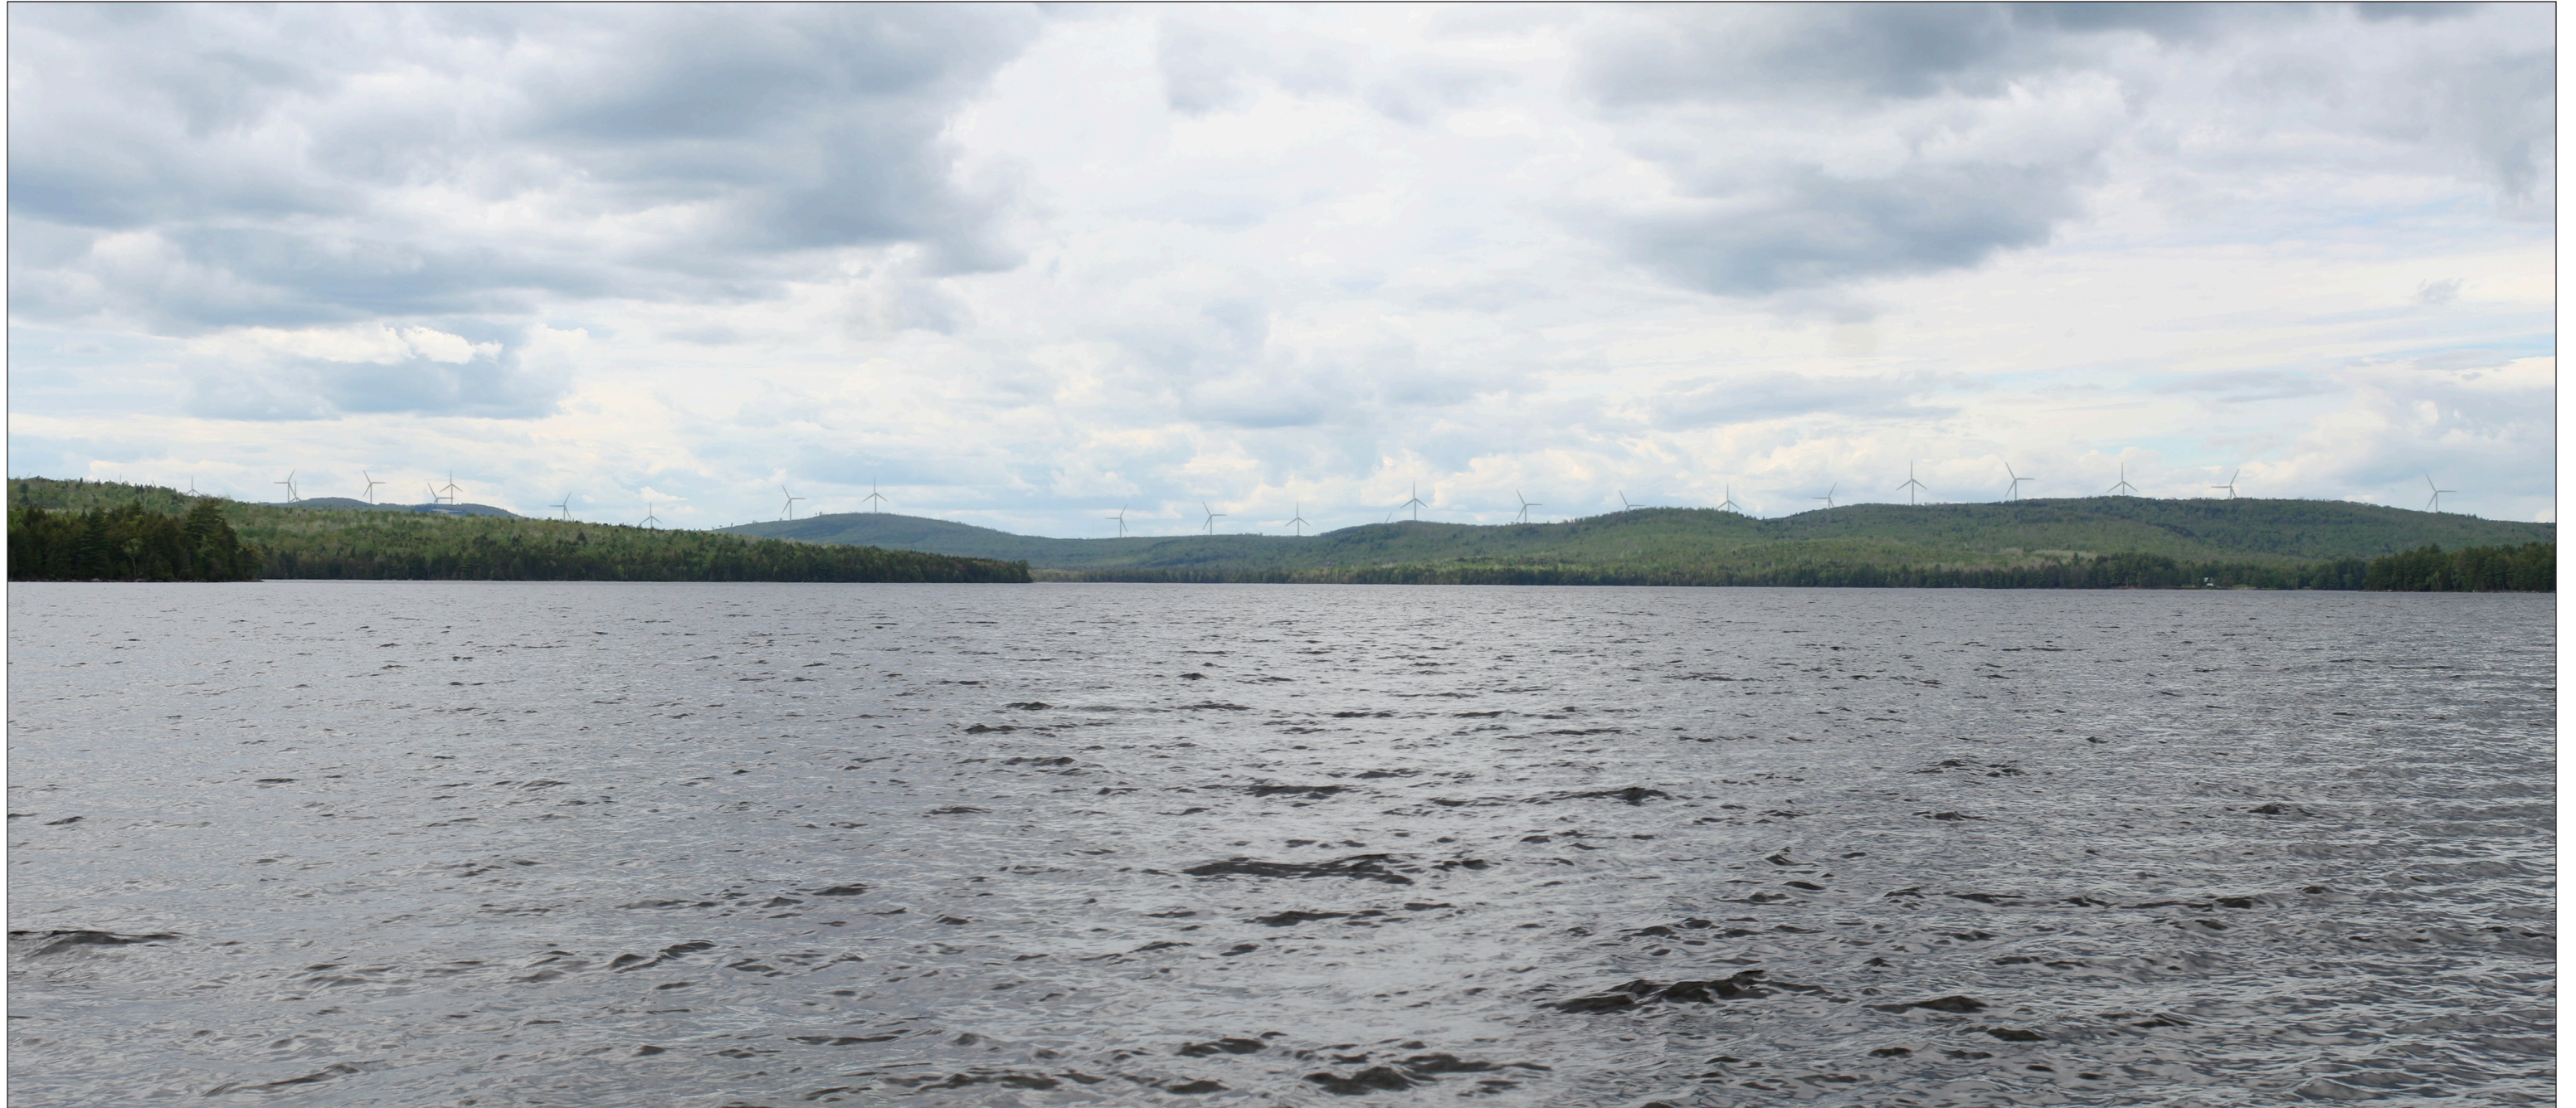
Exhibit 10: Visual Simulation from Pleasant Lake Boat Launch, T6 R1 NBPP

Existing Conditions Photograph

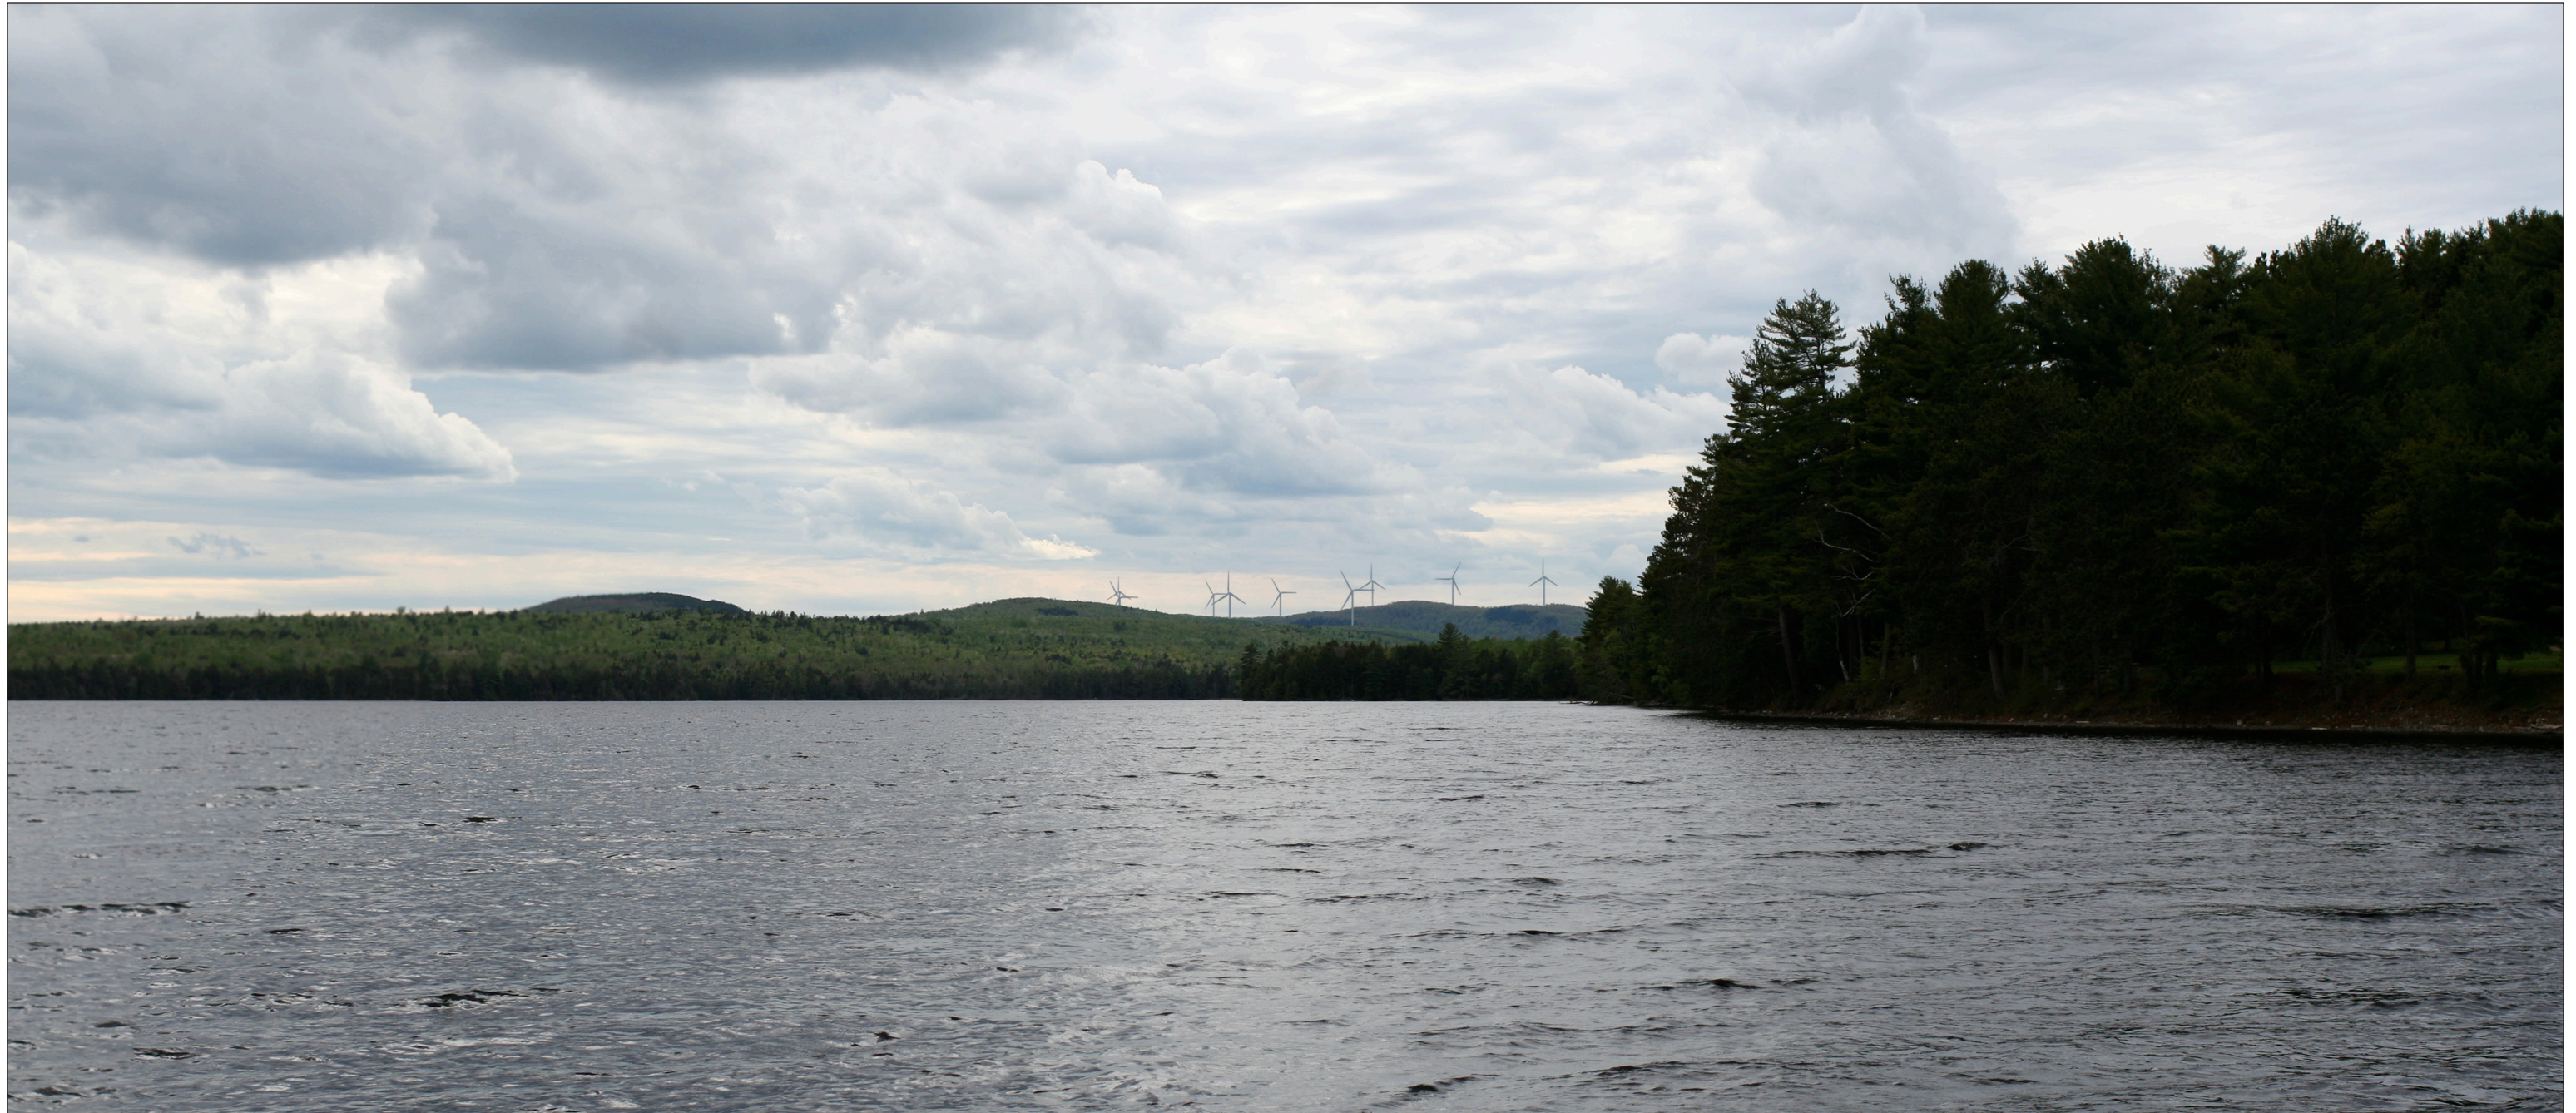
Exhibit 11: Visual Simulation from Pleasant Lake, Near Northern Shore, T6 R1 NBPP

Existing Conditions Photograph

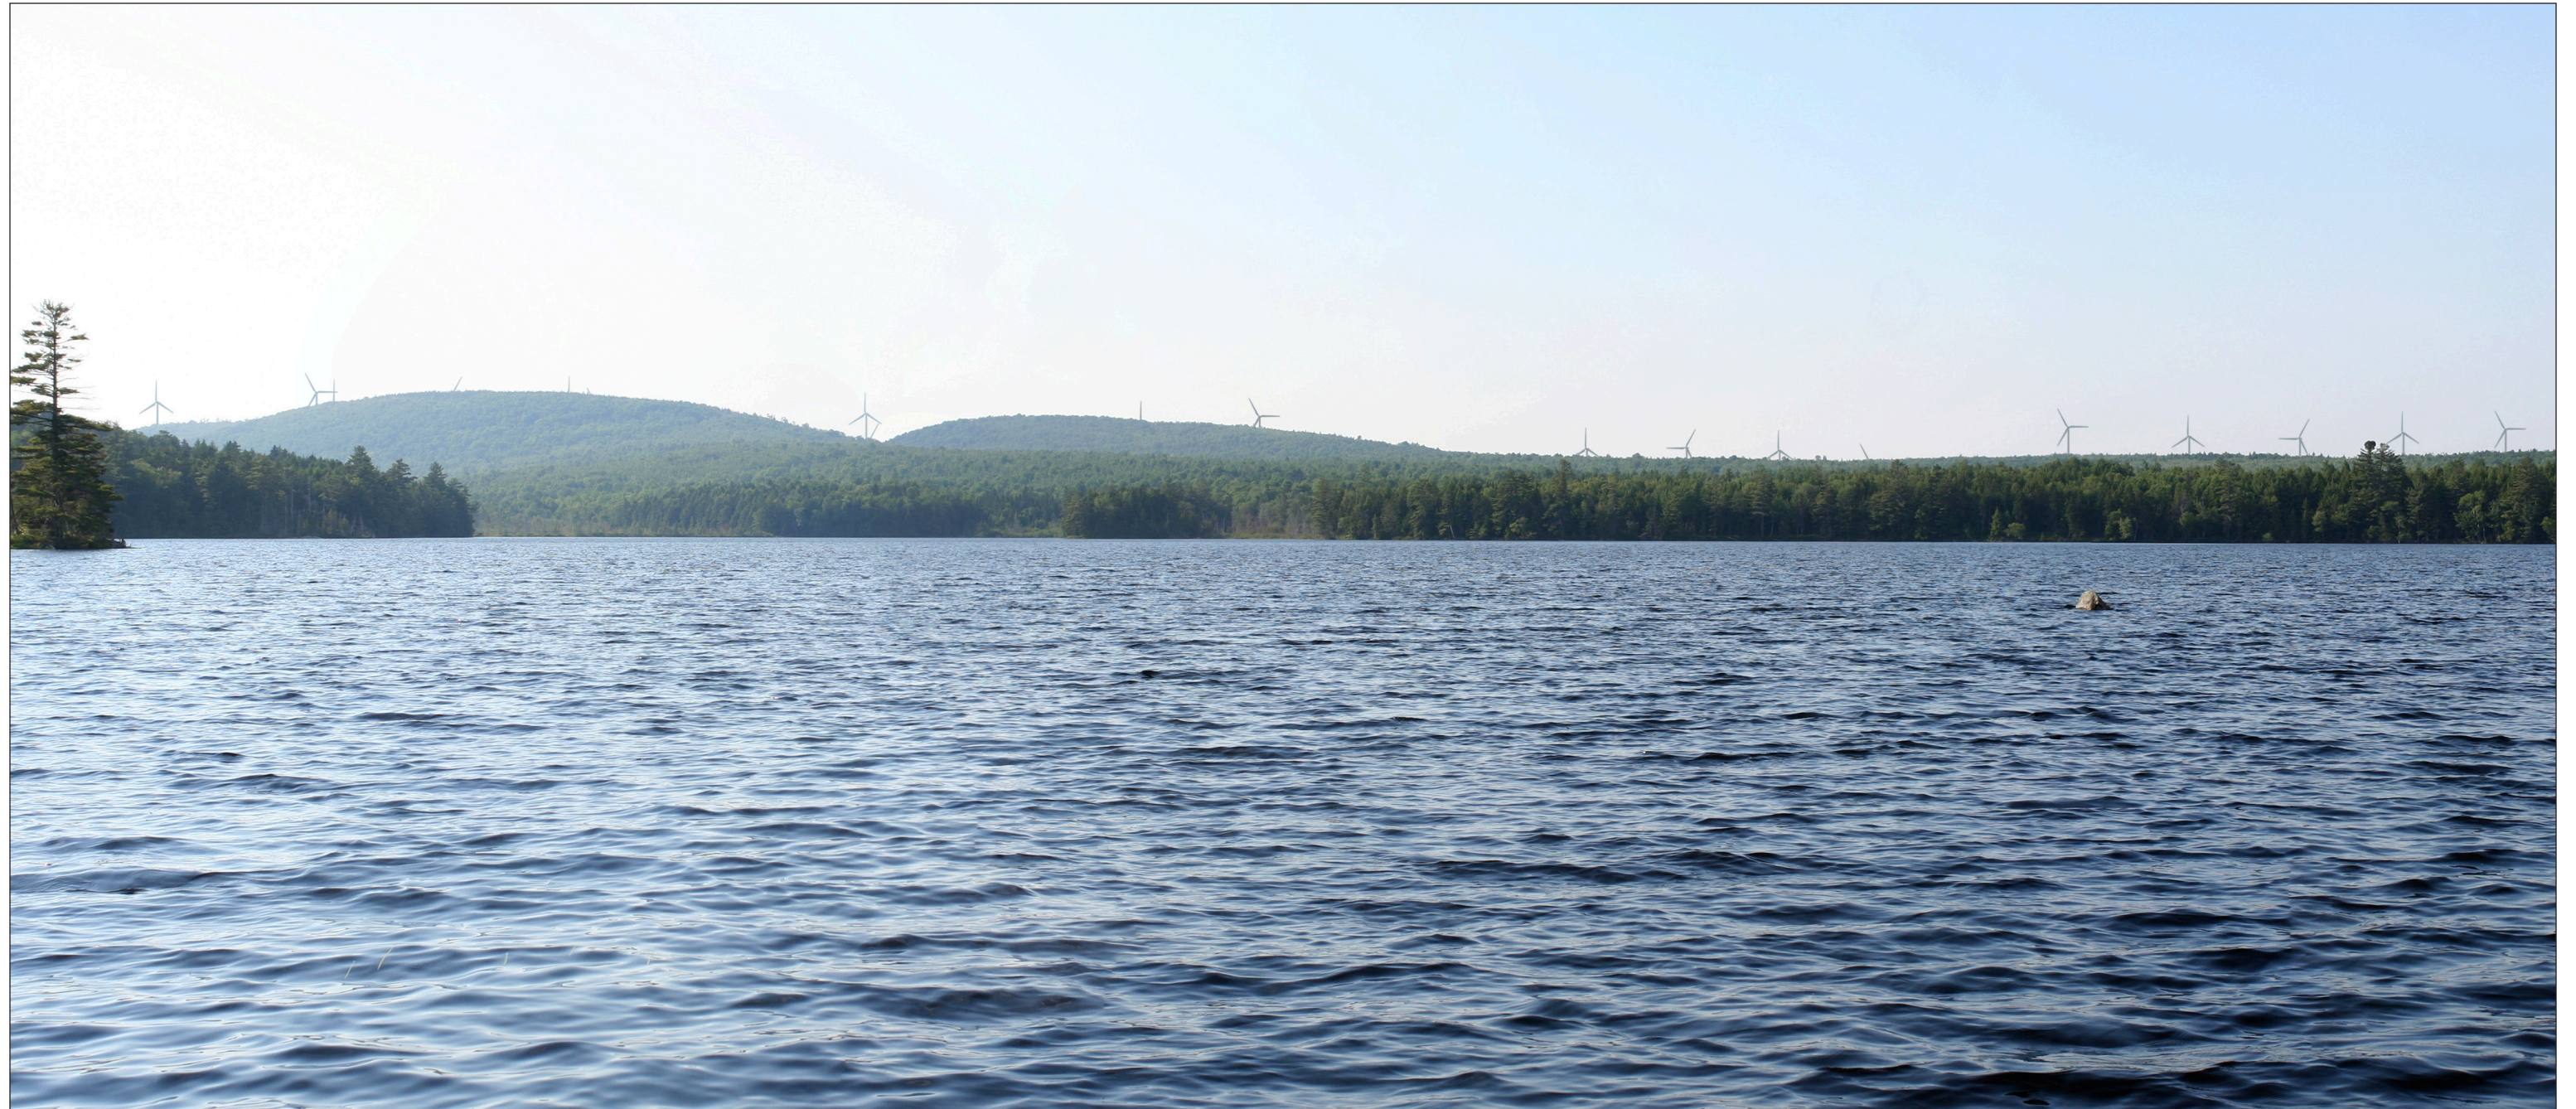
Exhibit 13: Visual Simulation from Shaw Lake, T6 R1 NBPP

Existing Conditions Photograph

turbines can be found in section 4.1.8 of Section 17 in the Application. See Exhibit F-2 for a visual simulation from Shaw Lake.

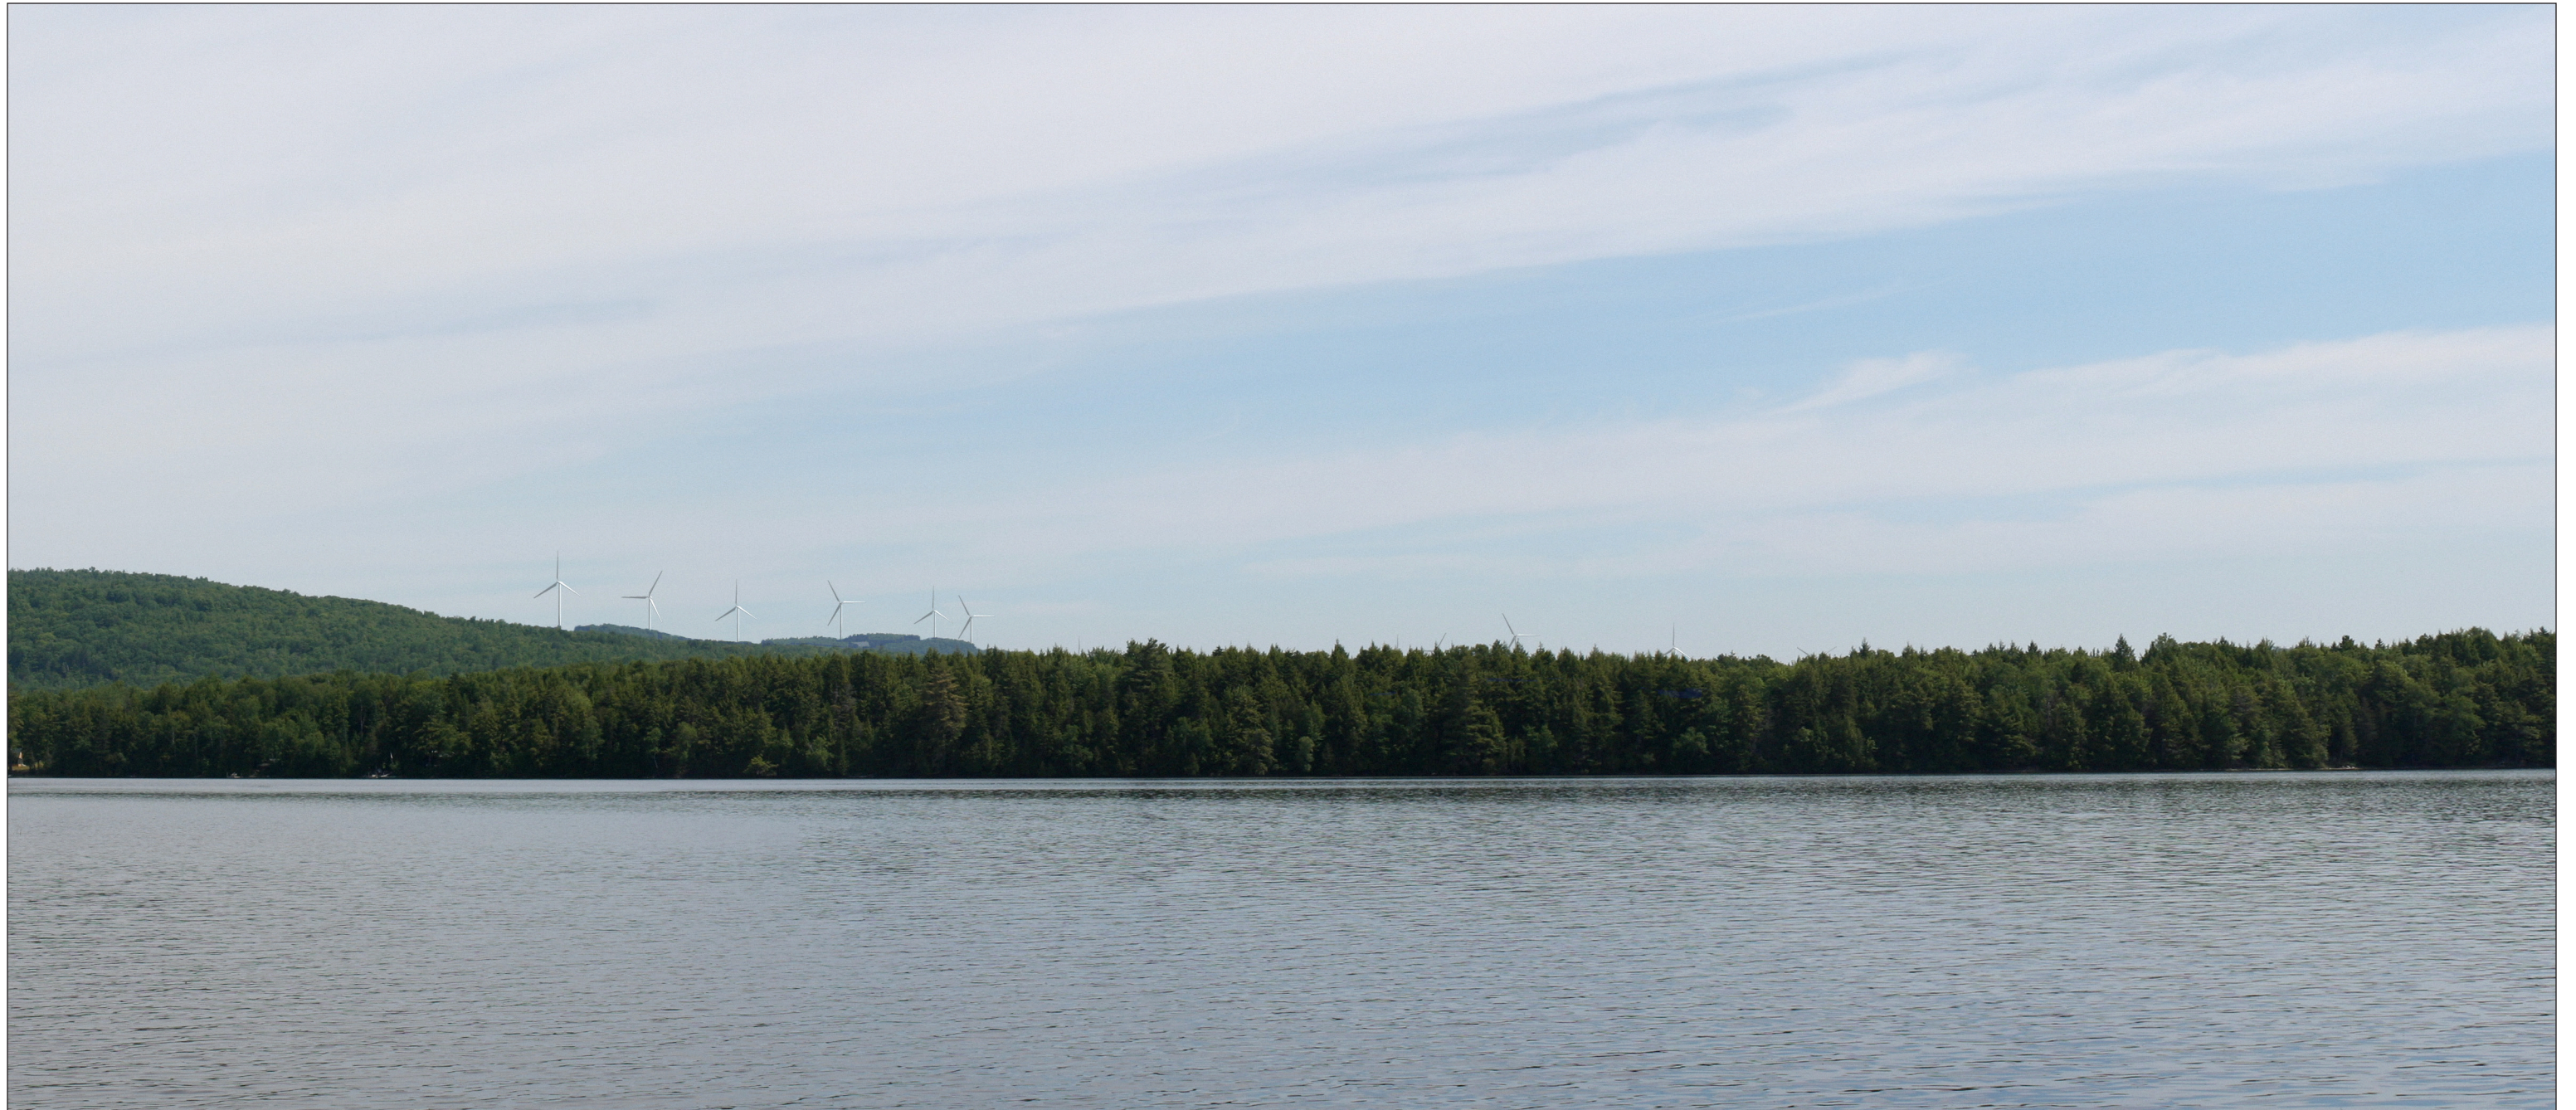
Exhibit 7: Visual Simulation from Duck Lake, Lakeville

Existing Conditions Photograph
