STATE OF MAINE
LAND USE REGULATION COMMISSION

IN THE MATTER OF DEVELOPMENT)	Pre-Filed Direct Testimony of
APPLICATION DP 4889)	David Raphael on behalf of
CHAMPLAIN WIND, LLC)	Champlain Wind, LLC
BOWERS WIND PROJECT)

On behalf of Champlain Wind, LLC, David Raphael of LandWorks is submitting this pre-filed direct testimony in support of the Bowers Wind Project (“Project”).

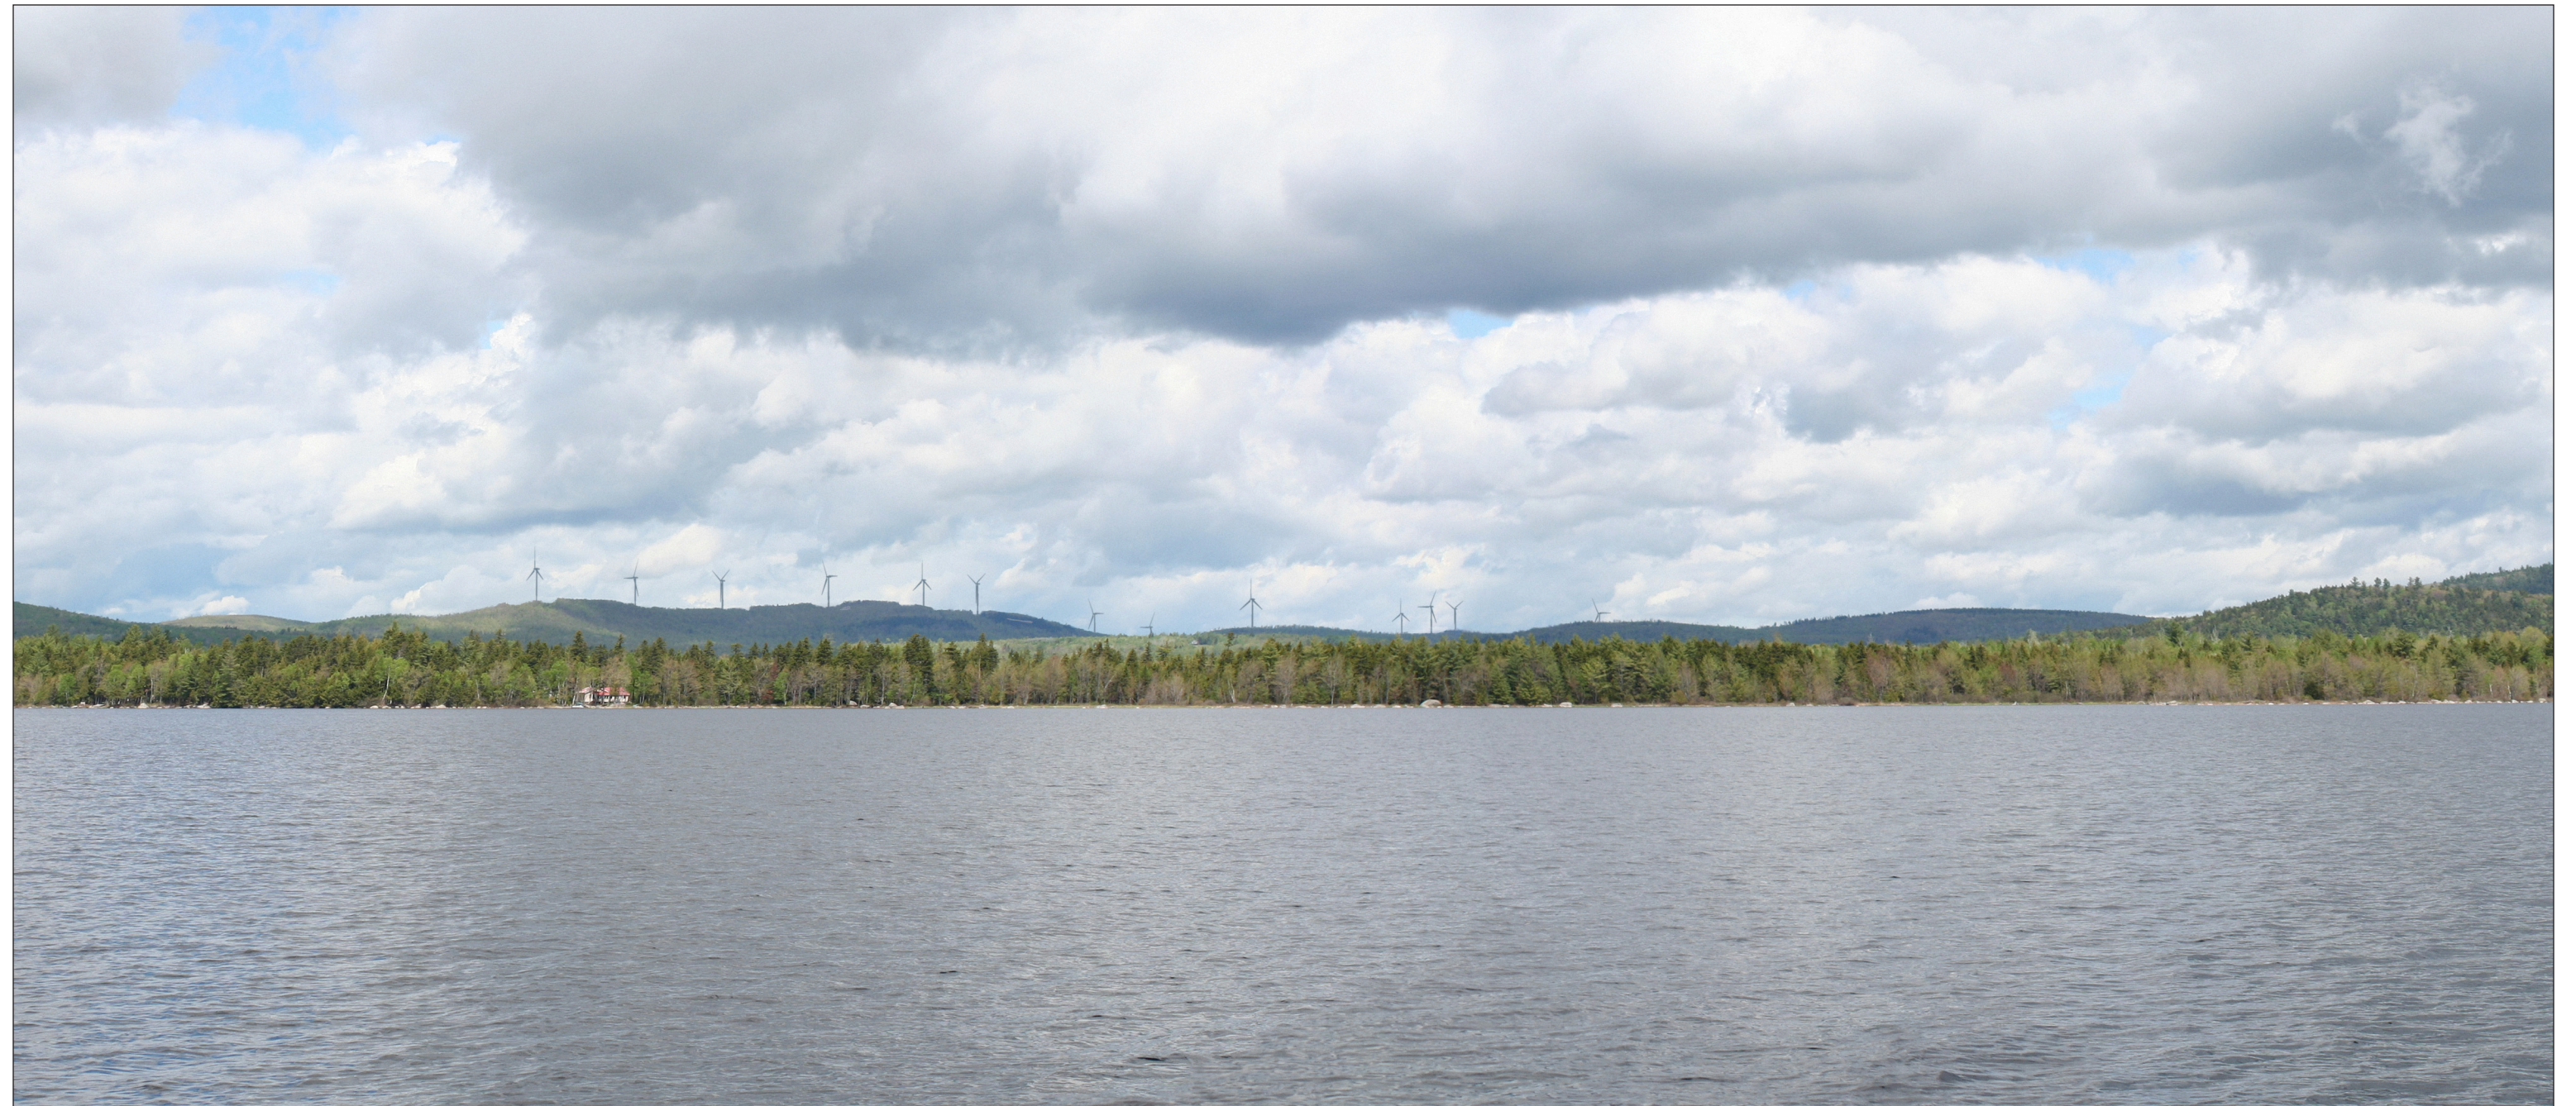
Exhibit 8: Visual Simulation from Junior Lake, Lakeville

Existing Conditions Photograph

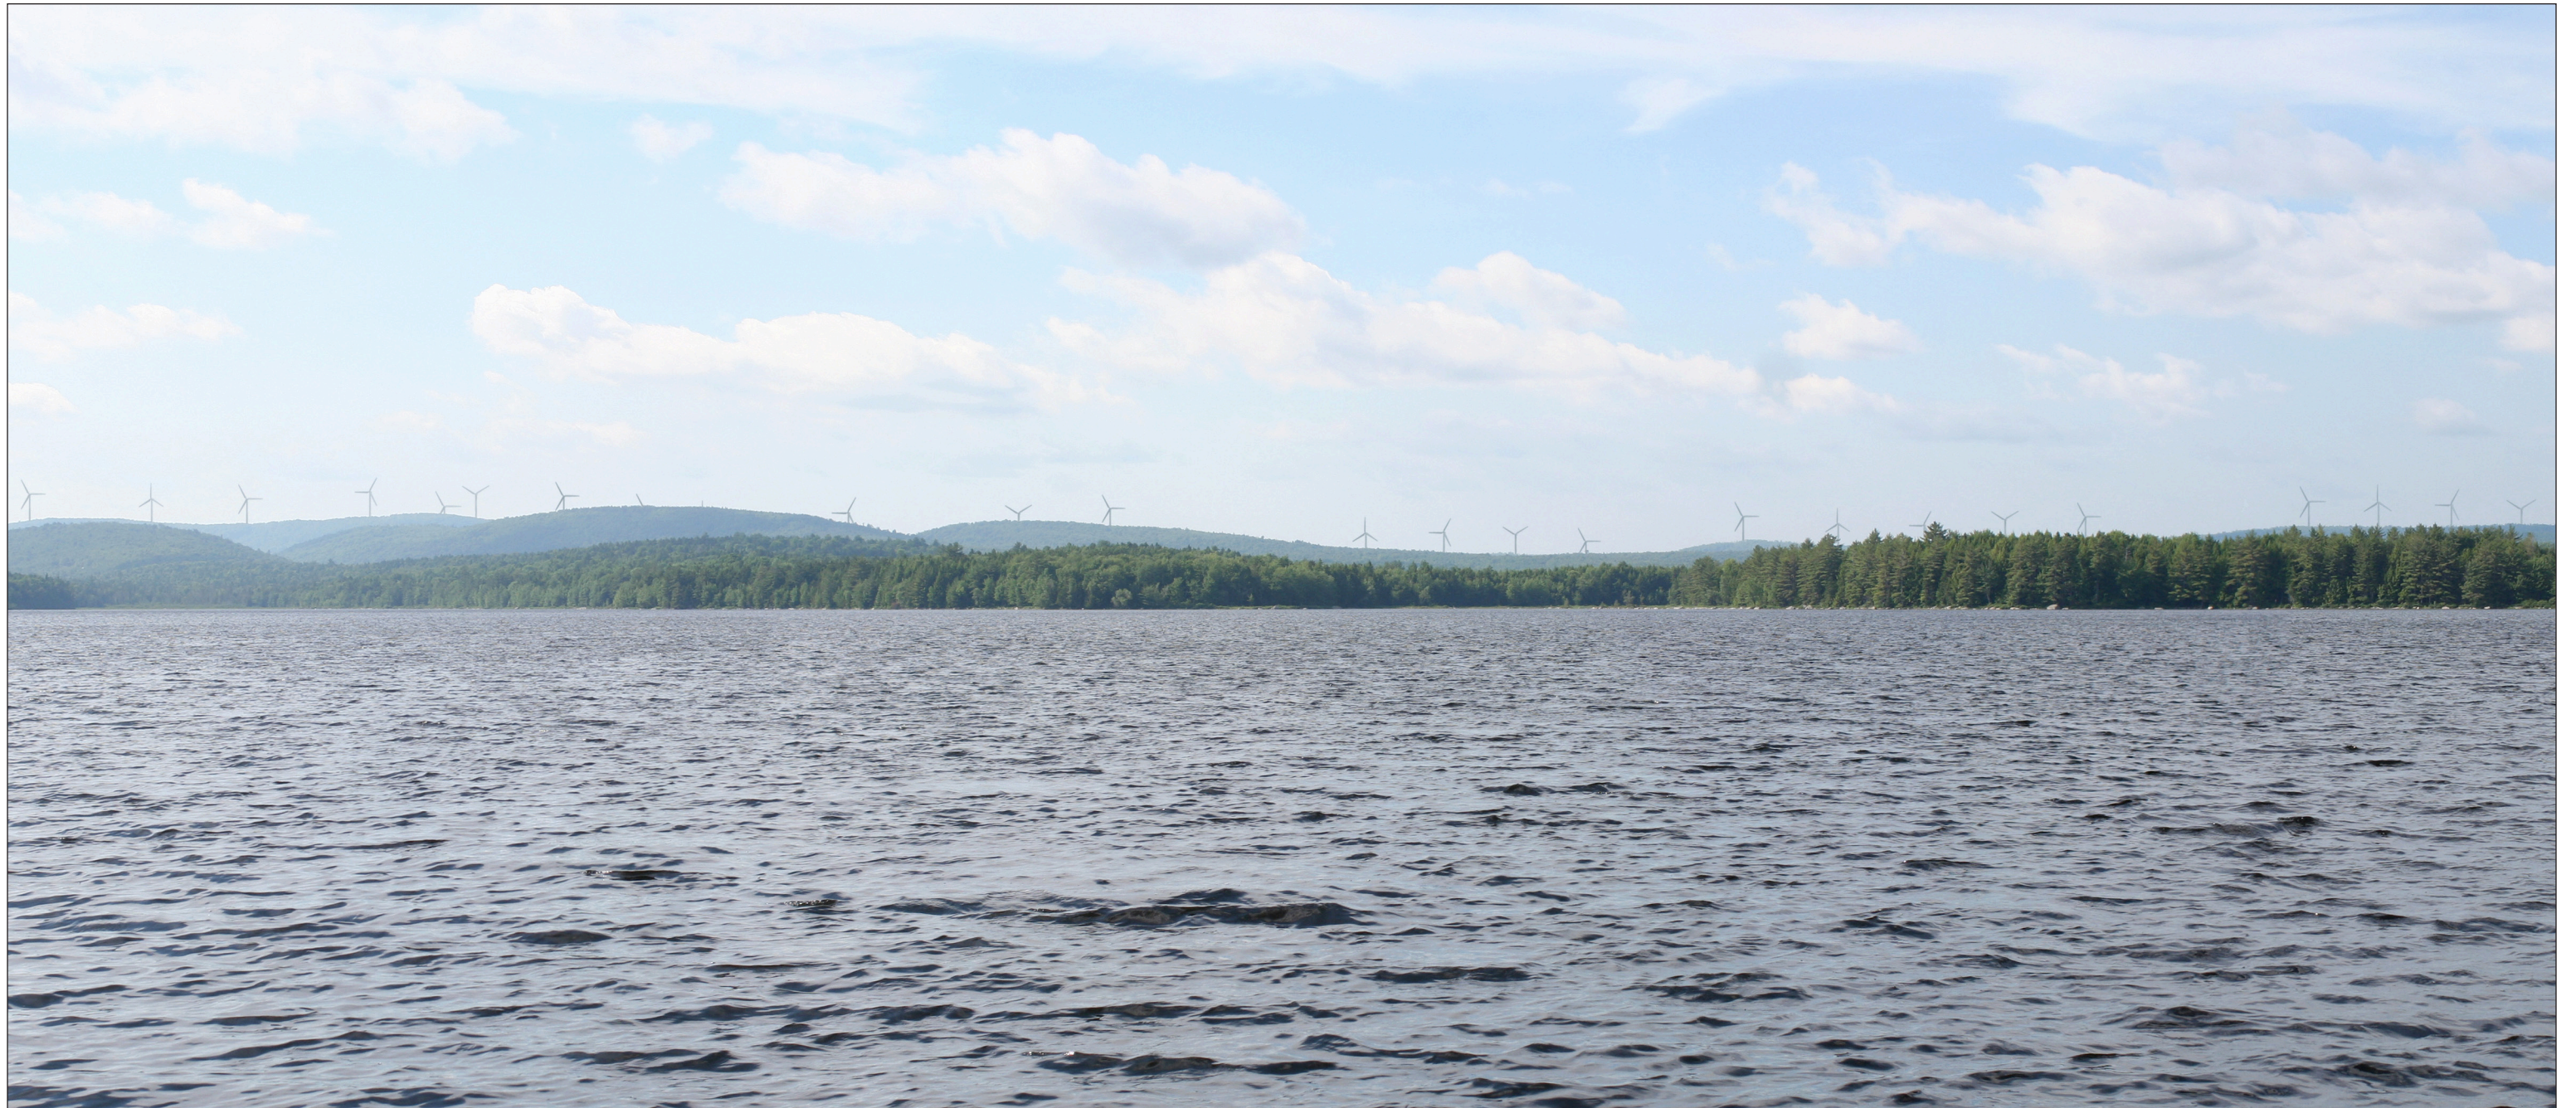
Exhibit 12: Visual Simulation from Scraggly Lake, Pukakon Twp

Existing Conditions Photograph

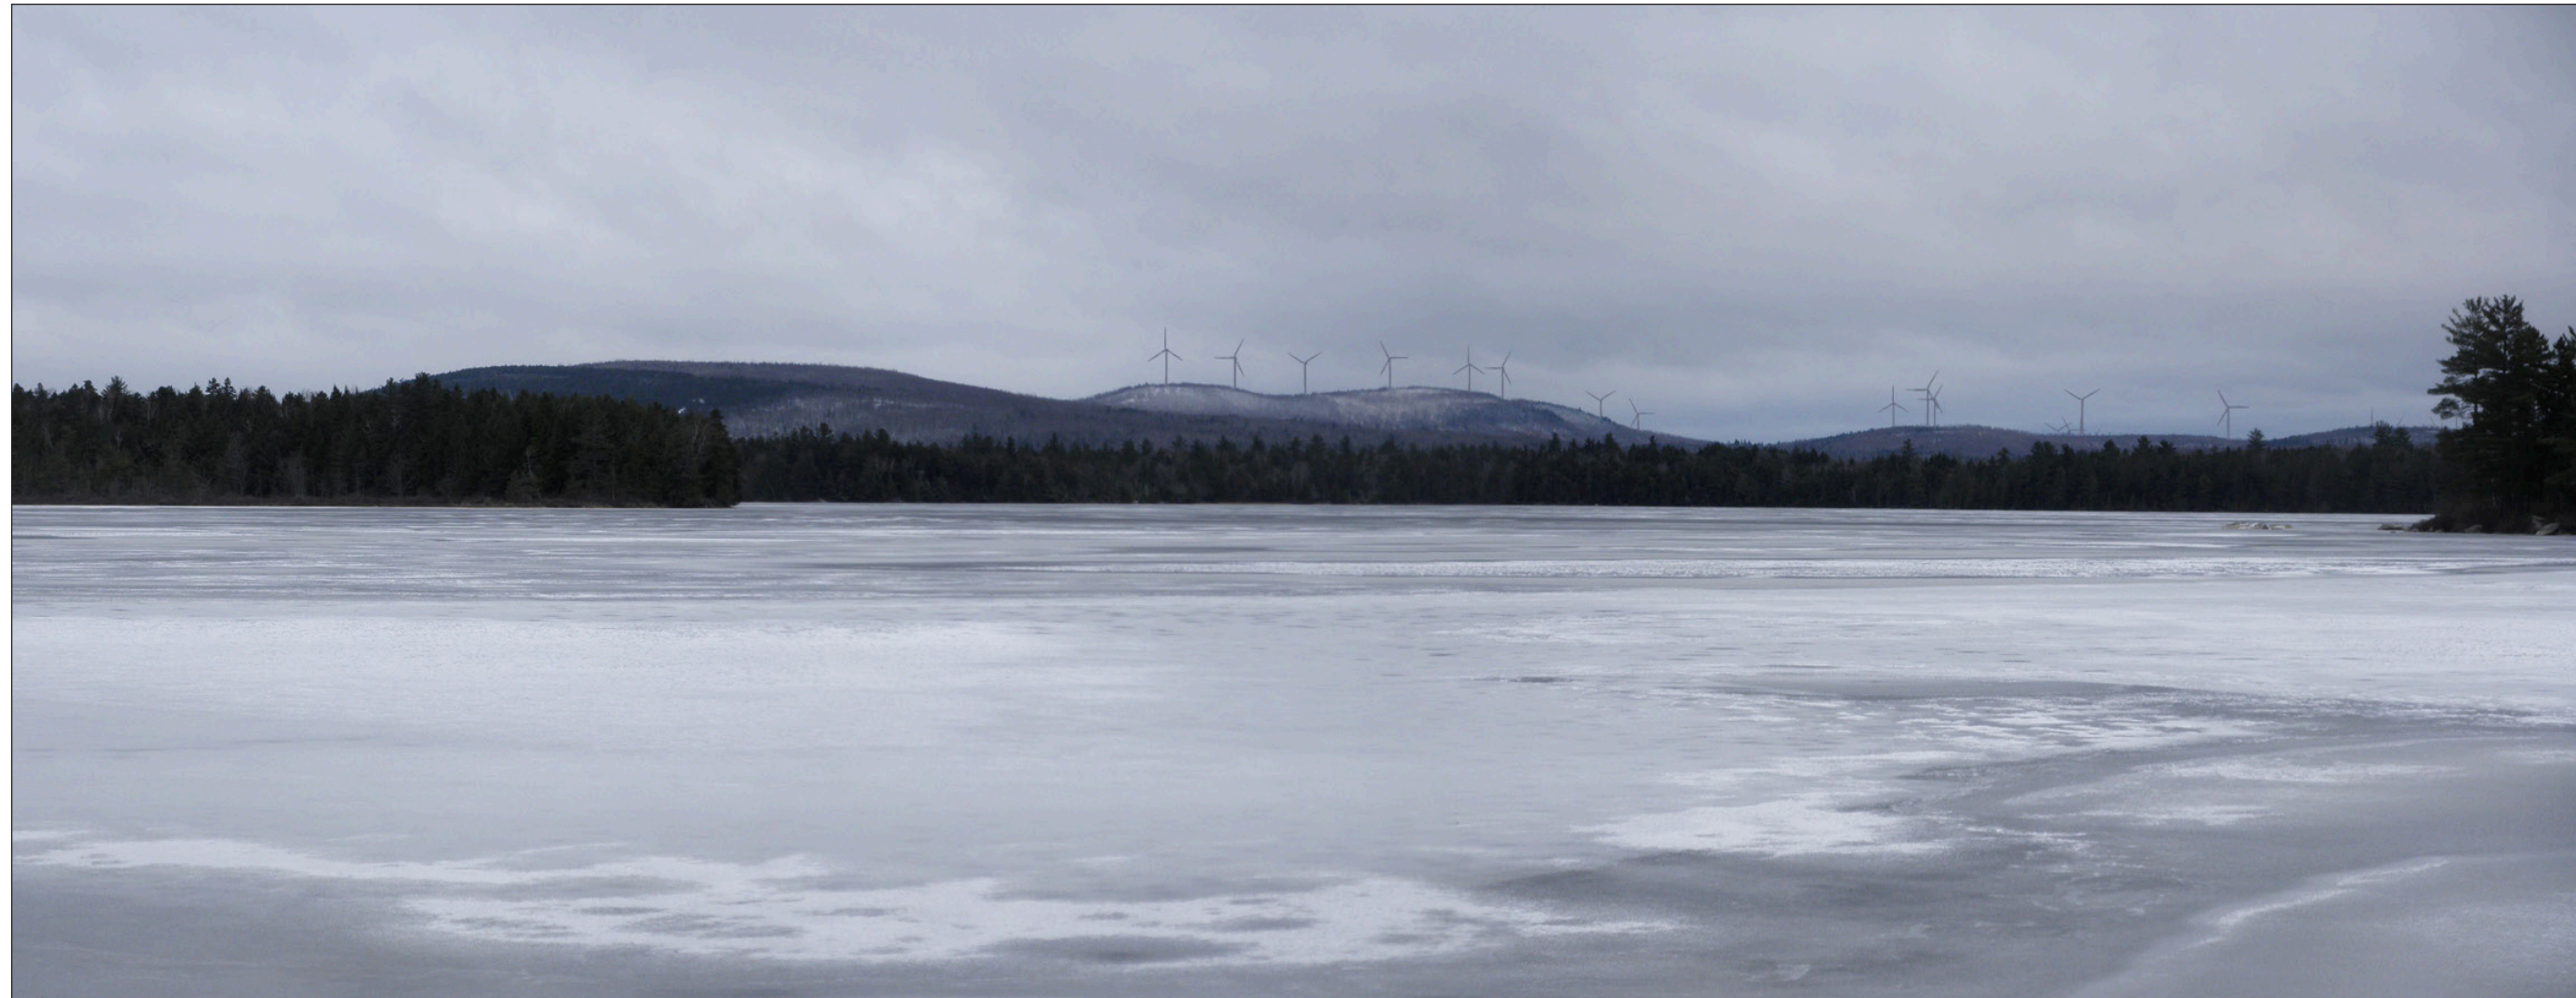
Exhibit 9: Visual Simulation from Keg Lake, Lakeville

Existing Conditions Photograph

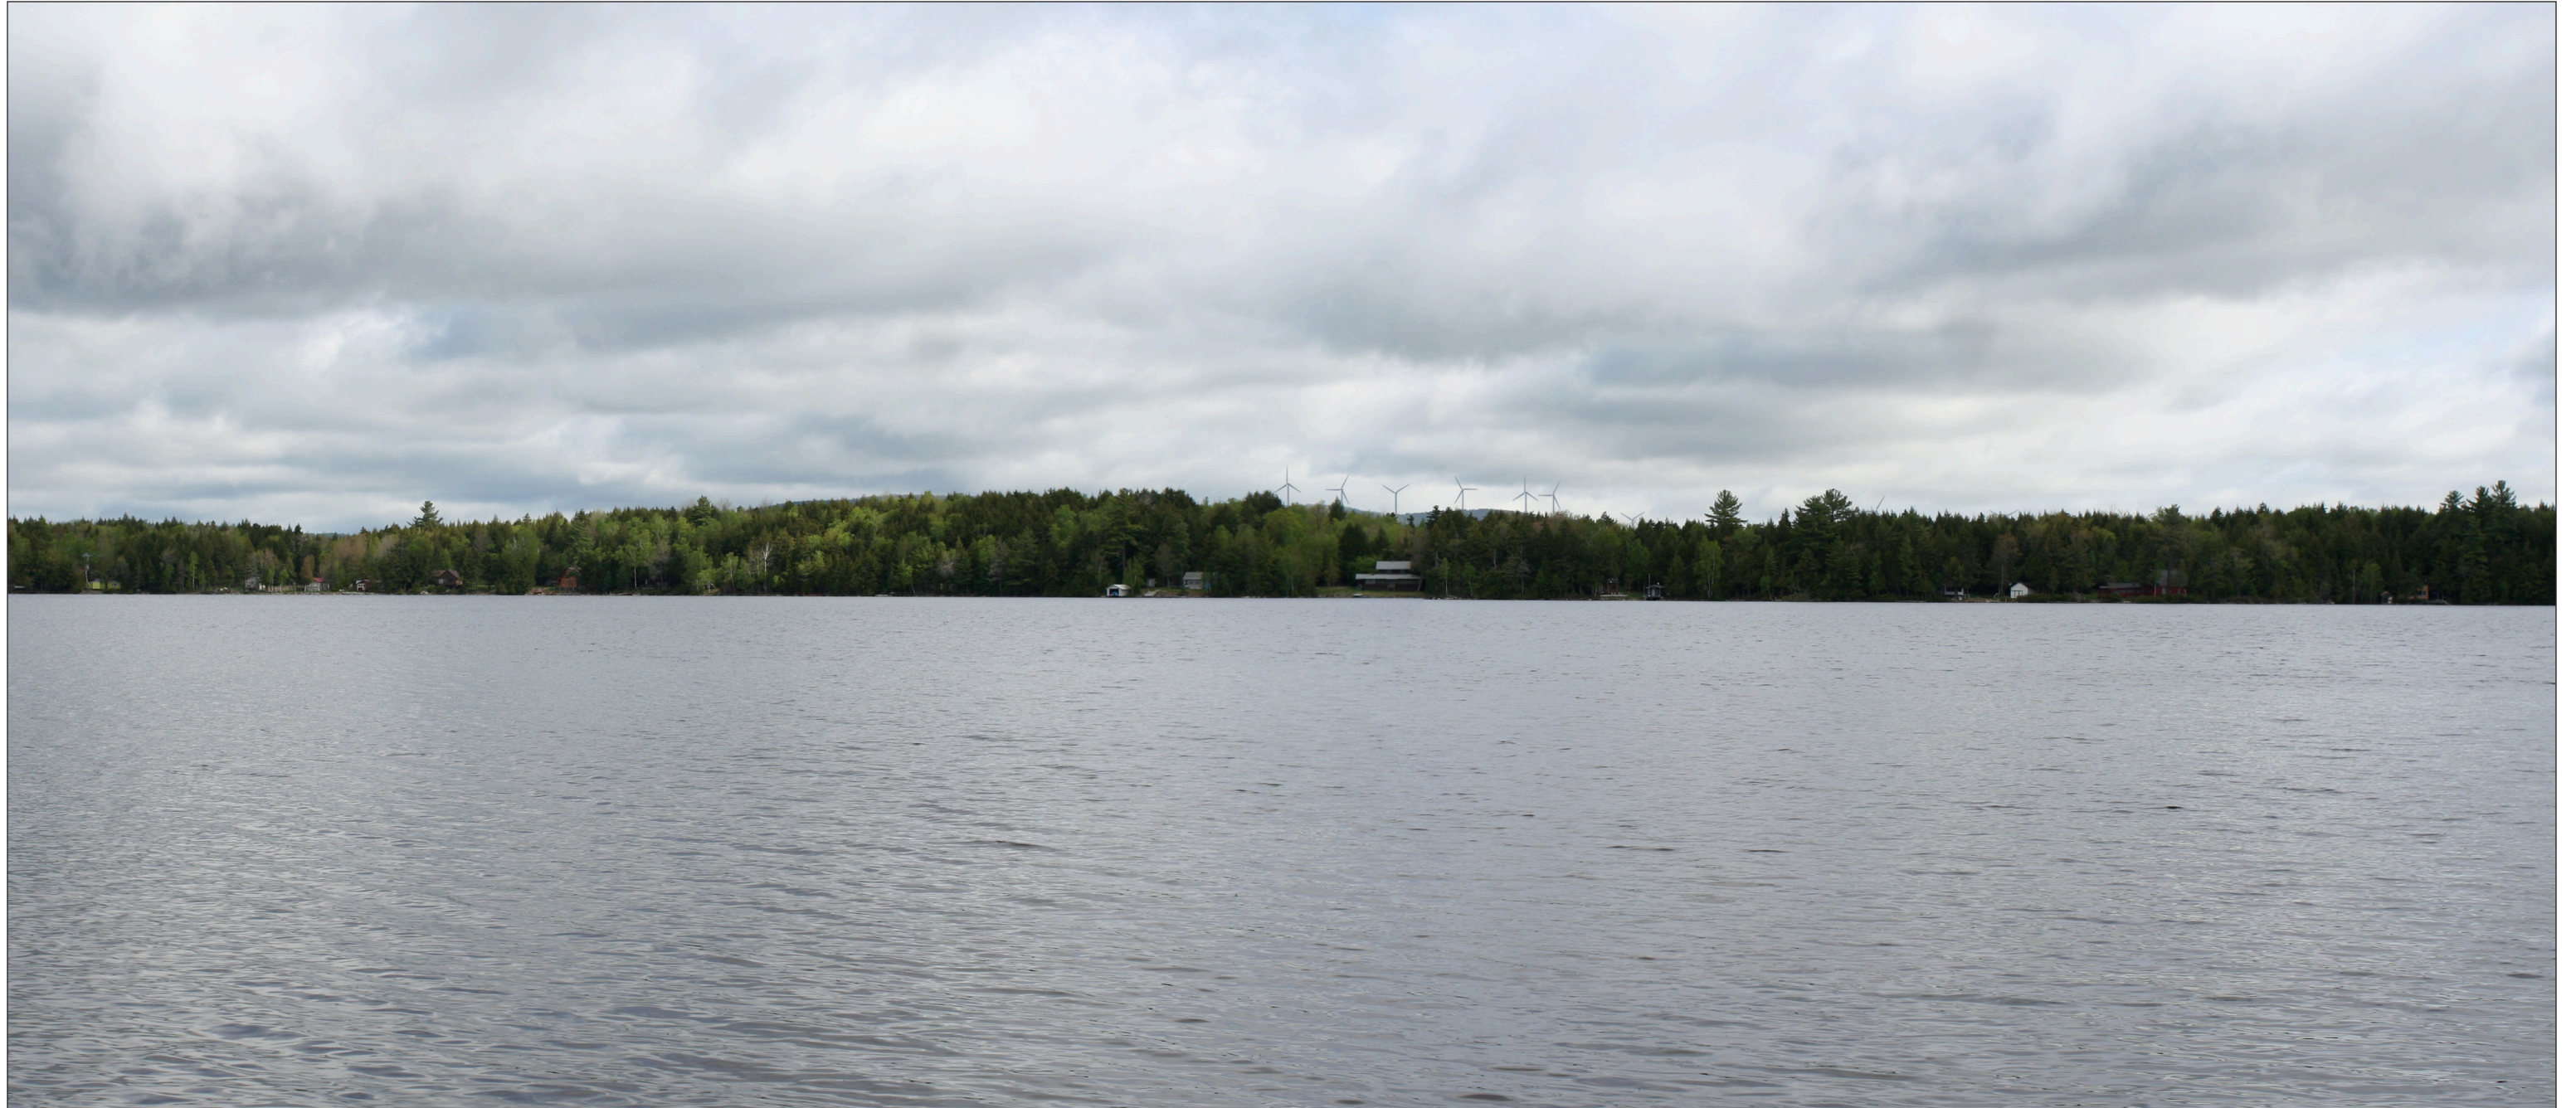
Existing Conditions Photograph
