RE: INDIAN POND PROJECT, FERC NO. 2142
STUDY PLANS FOR FISHERIES ENHANCEMENTS

Indian Pond Project, FERC No. 2142

Section 3.3.3.C Field Evaluation of Potential Aquatic Restoration Projects

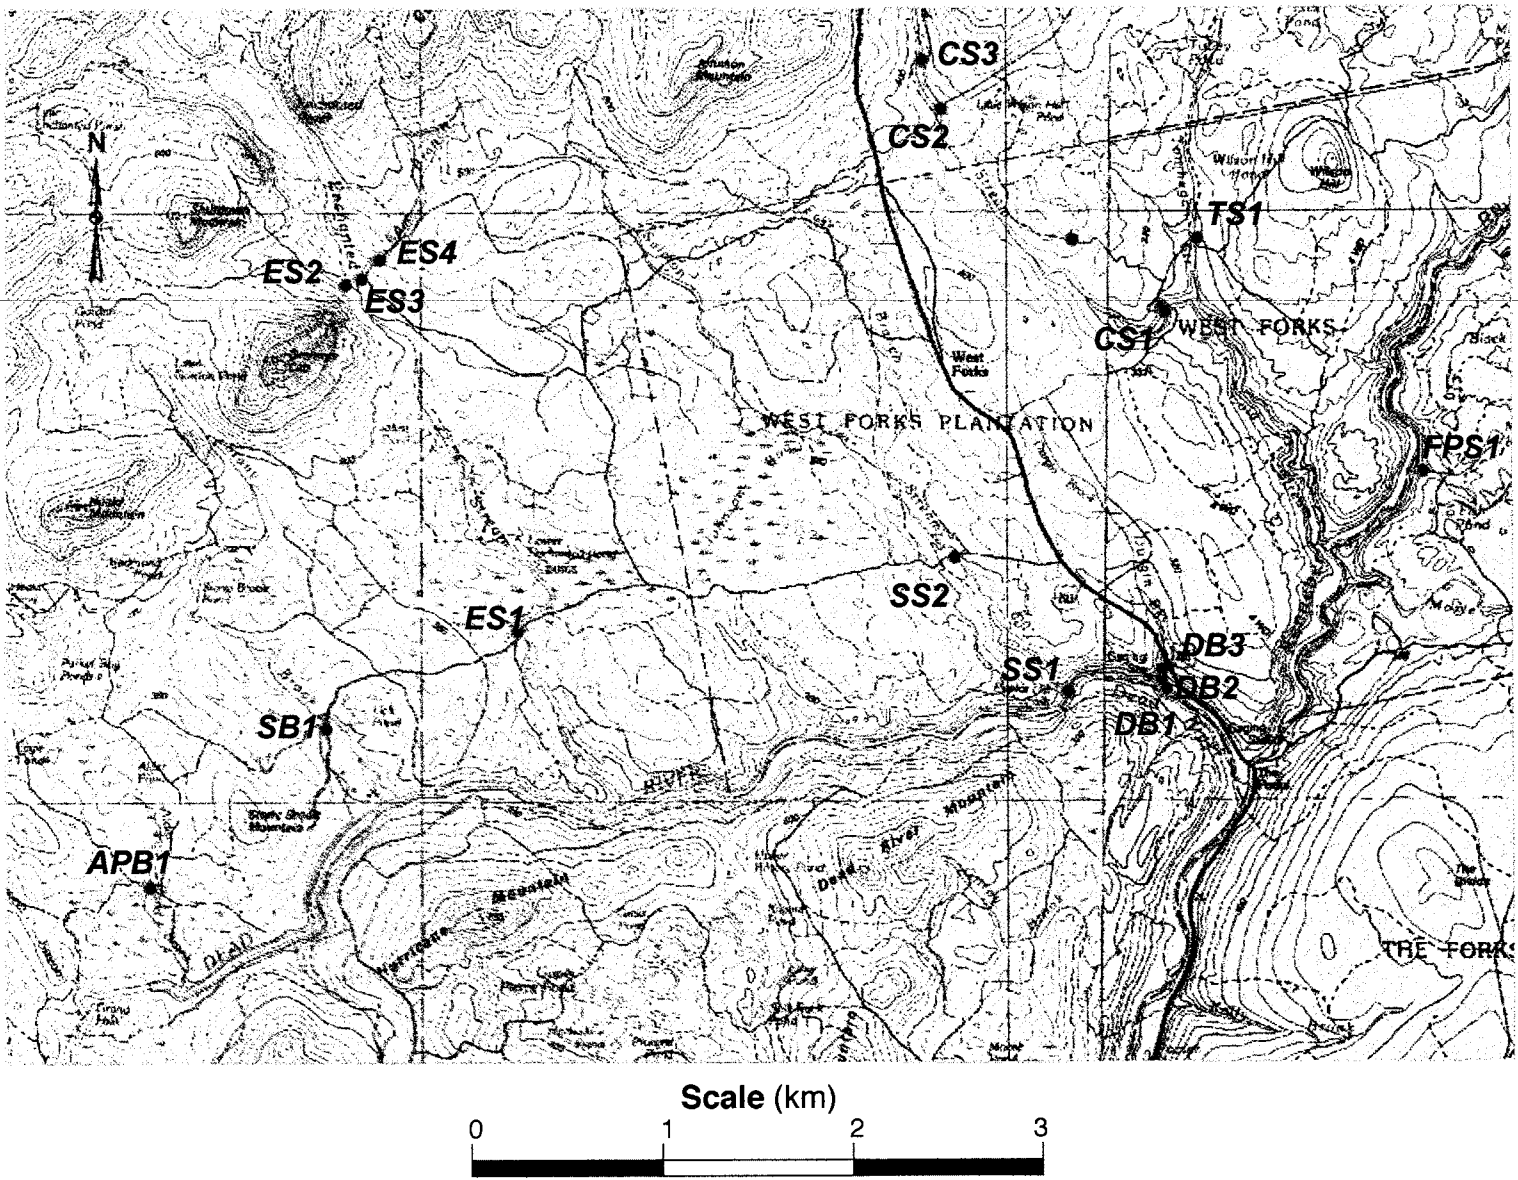
On August 22 and 23, 2006 representatives from the Fisheries Committee inspected the eight streams at seventeen locations where logging roads provided access (Figure 1). This was not an detailed field investigation involving the measurements of hydrogeomorphic parameters or collection of biologic data, but a preliminary assessment of the streams to determine which locations might warrant further investigation. At each locations, the channel conditions were examined and areas of degradation and poor habitat were identified (Table 1). The participants discussed the need and feasibility of modifying the stream channel or installing structures at these locations.

Figure 1. Locations visited during preliminary stream assessment, August 22 and 23, 2006.

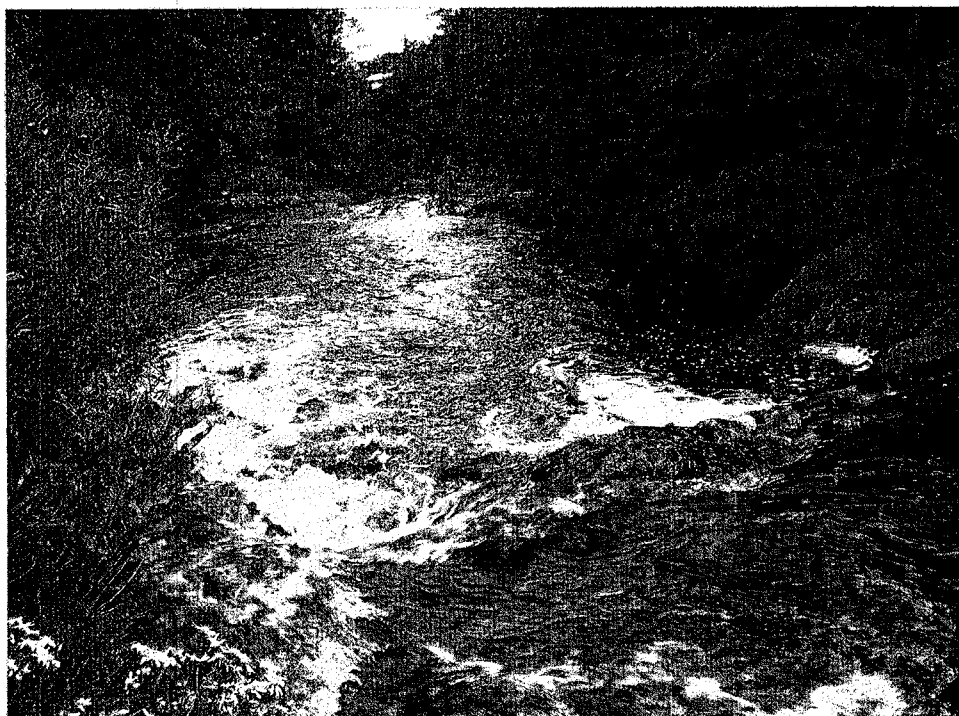
Salmon stream is accessible downstream of a logging road crossing (SS1). Here, the stream is a C3 to C2 type, slightly entrenched system developed in very coarse glacial materials with an approximate channel gradient of 0.010 (estimated from USGS topographic map). Further upstream, the channel becomes wider and less steep (B3-type morphology). The channel bed is dominated by cobble and boulders and is characterized by a series of rapids with irregularly spaced pools 2 to 4 m across and estimated to be 0.5 to 1.5 m deep (Figure 9). Channel widths were generally less than 8 m, with stable banks extending 0.5 to 2 m above channel bottom (Figure 10). Substratum appeared to be predominantly gravel and cobbles, with numerous boulders up to 1.5 m scattered throughout the channel. Stream was well shaded by the forest canopy, with fallen trees providing good habitat a several places along the channel (Figure 11). Water was clear, cold, and appeared well-oxygenated. Numerous invertebrates could be found on undersides of rocks picked up from the stream bottom.

Figure 10. Salmon Stream at SS2 (Lower Enchanted Road bridge; view downstream).

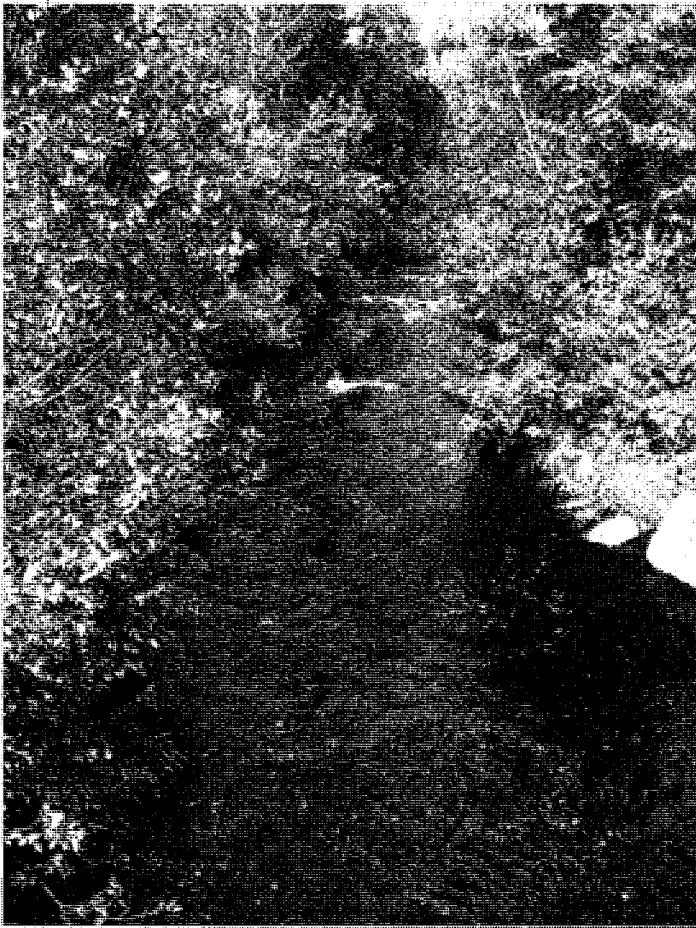
Figure 11. Salmon Stream at SS2 (Lower Enchanted Road bridge; view upstream).

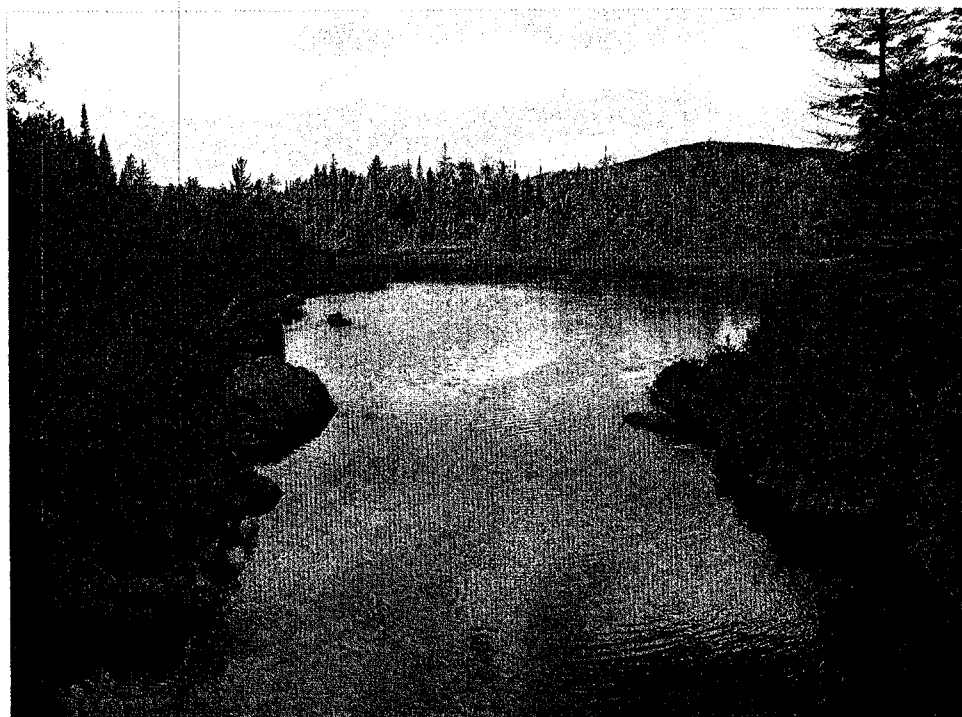
In its lower reaches, Enchanted Stream is accessible as it flows out of Lower Enchanted Pond (ES1). Here the stream is 11.9 m wide and relatively warm (18.5 °C). On the downstream side of Lower Enchanted Road bridge the channel widens downstream of the bridge, due to a bedrock grade control (Figure 15). A broad backwater area with lily pads exists on the right side of the channel downstream of the bridge. Further downstream, an old pulp chute is present on the left bank (behind the aluminum travel trailer in Figure 15). This feature, along with an unnatural-looking line of boulders in the woods further downstream, are believed to be remnants of former logging operations. A broad, vegetated floodplain is present on both sides of the stream with water flowing visibly through the bouldery hyporheic zone where it exposed around tree roots.

Figure 16. Enchanted Stream at ES1 (Lower Enchanted Road bridge).
View is upstream toward Lower Enchanted Pond.
